2021 PA Turnpike Accomplishments

Roadway Failures

Forensic Testing of Existing Roadway Structure

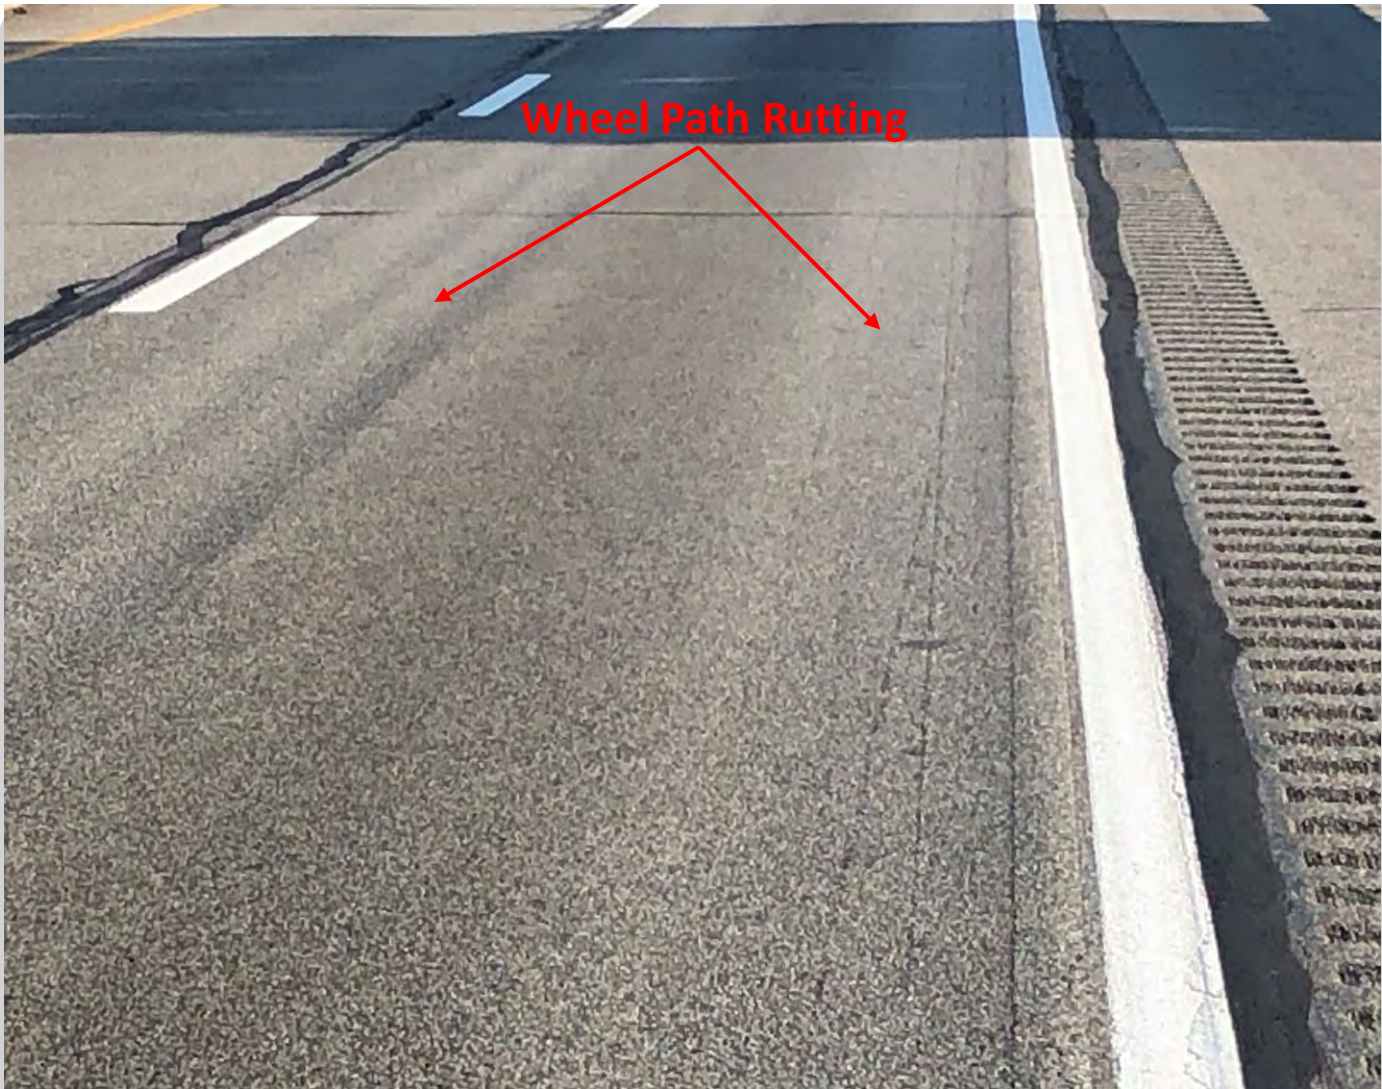
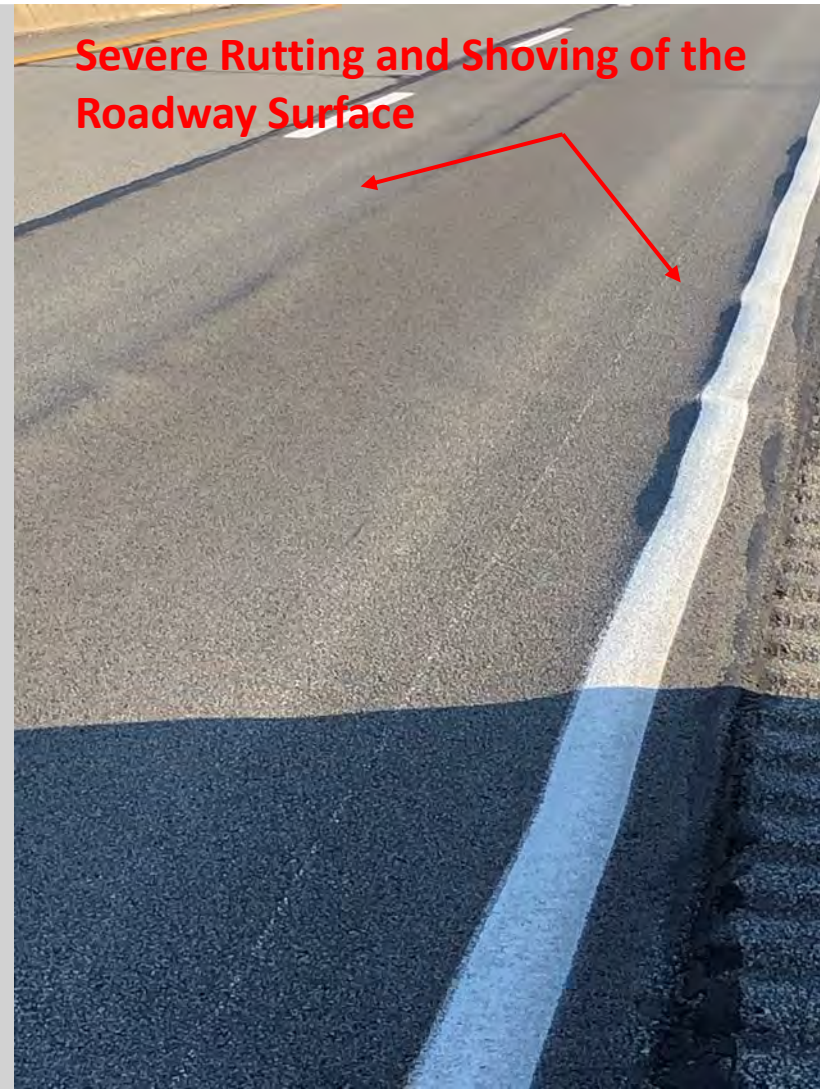
Rutting of Roadway Surface

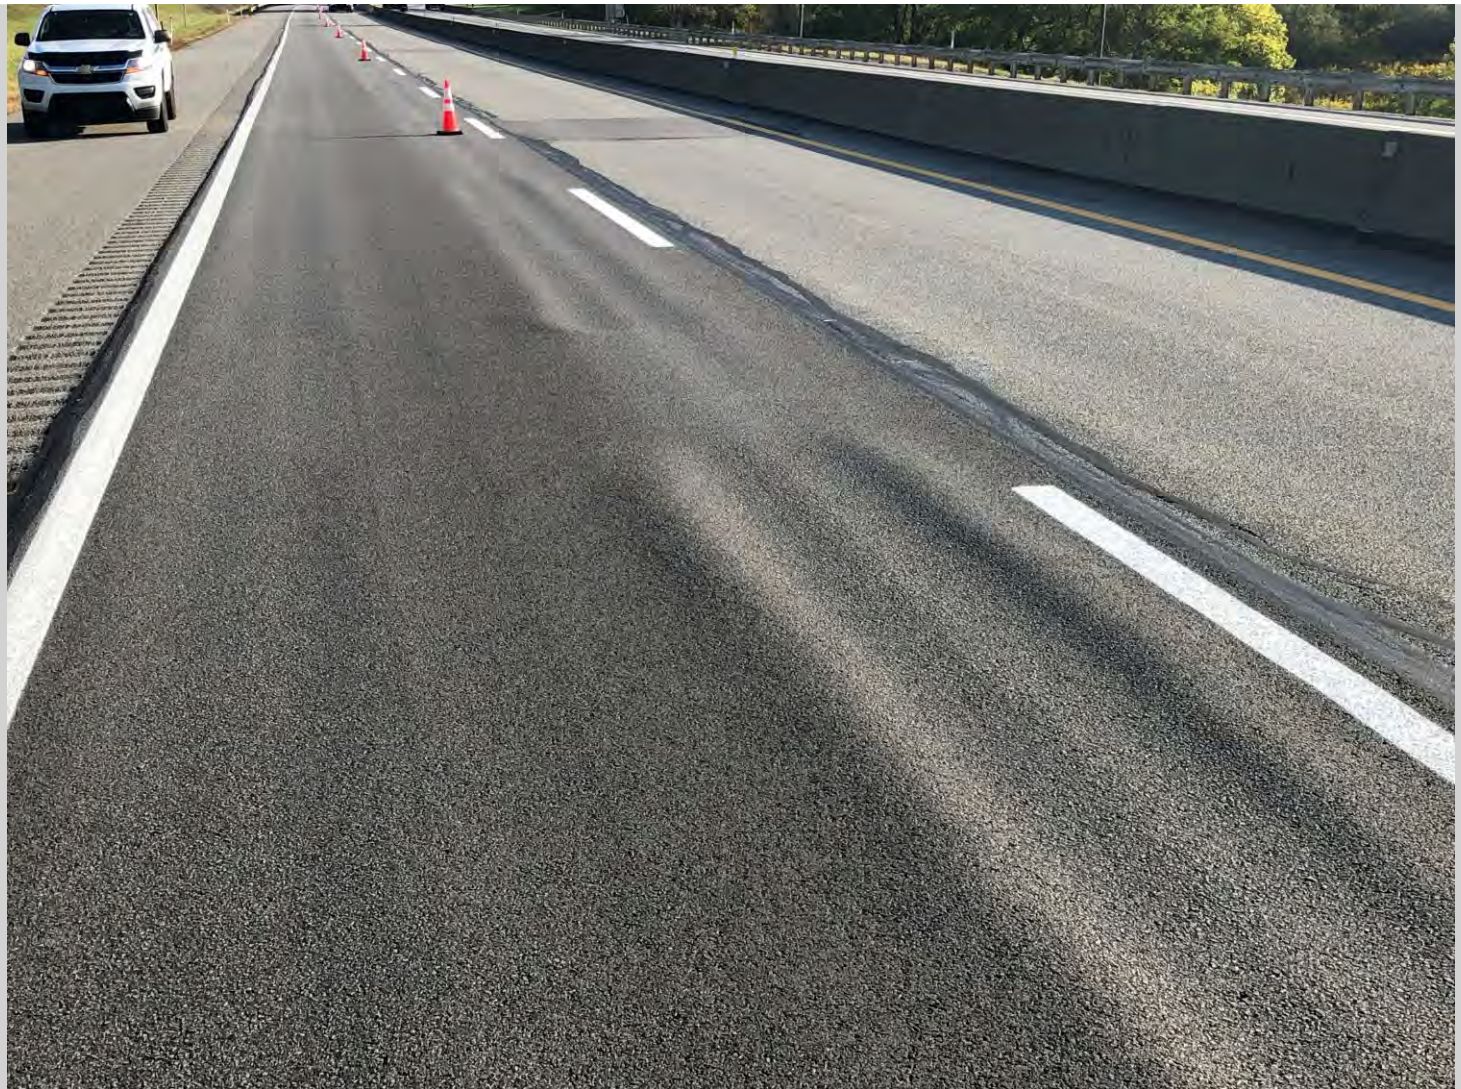
Extensive Rutting

Cause of Rutting ?

Failure of the existing binder / leveling coarse was the most probable cause of the rutting distresses. Documentation had estimated the age of the intermediate binder / leveling coarse to be nearly 50 years old. The area had also been resurfaced multiple times while the binder and leveling remained in place. Aggregate structure within the binder coarse had been severely damaged. A majority of the coarse aggregate within the material had been broken and structural integrity had been lost. Without having the load bearing capability, the binder coarse had succumbed to the continuous pressures of live traffic loads. Without the structural support beneath, the wearing coarse rutted significantly.

The repair required milling to remove the damaged binder/leveling coarse and repaving with 19mm Wearing PG 64E-22 asphalt mixture.

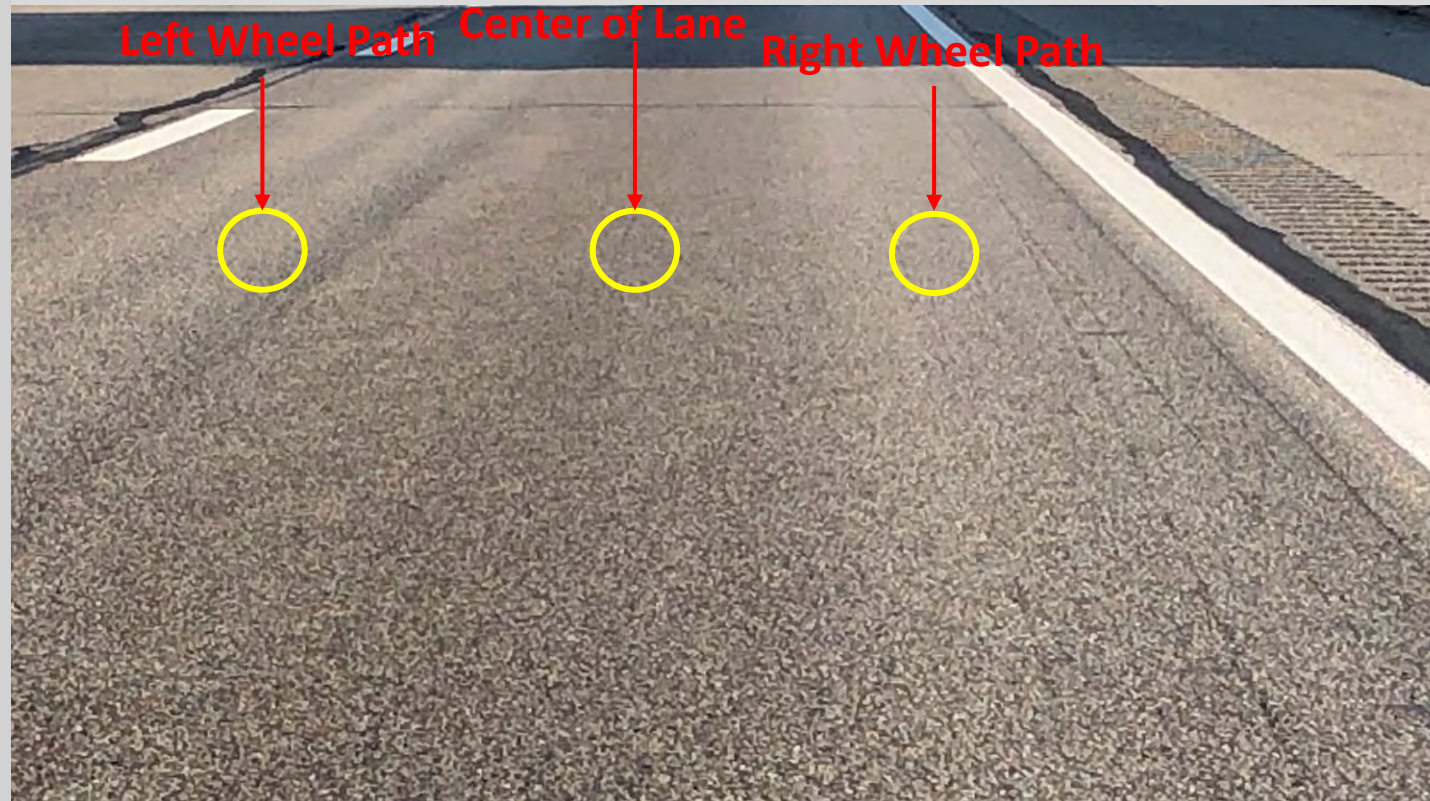
Roadway Coring

We decided to drill roadway cores at the tenth mile posts for the length of the distressed roadway area. Cores were drilled to the depth of the existing concrete slabs to determine the condition of the underlying asphalt layers.

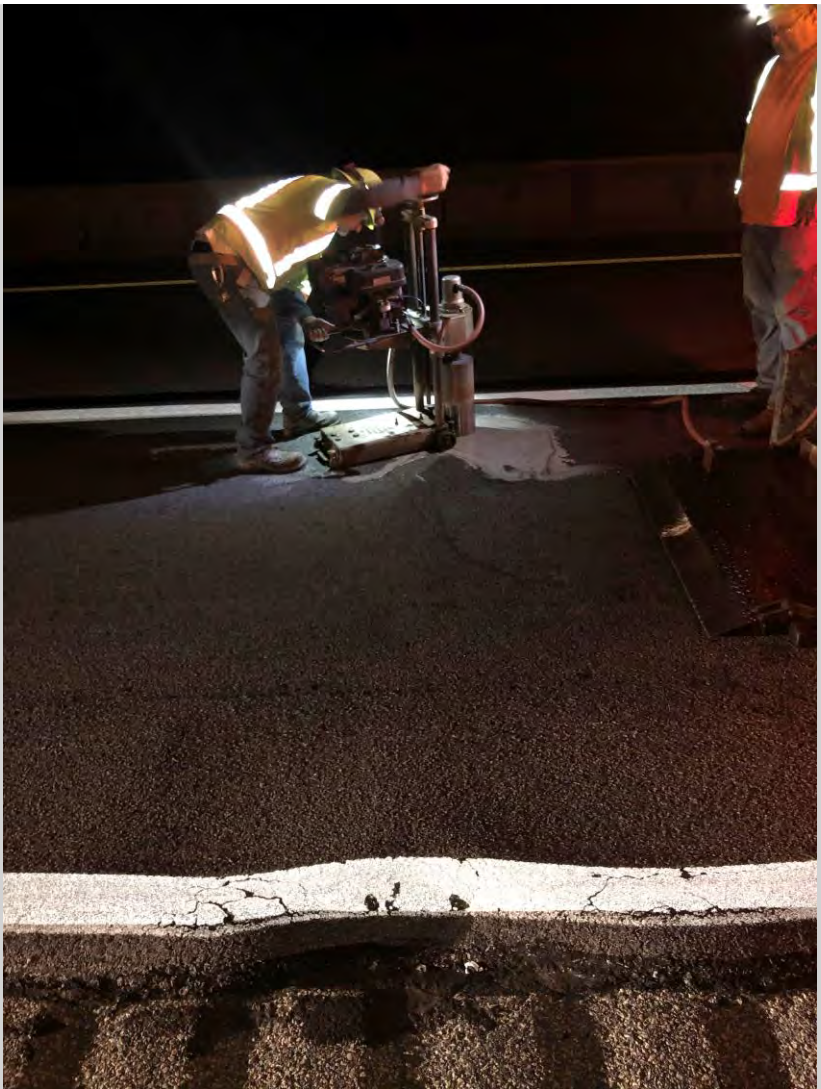
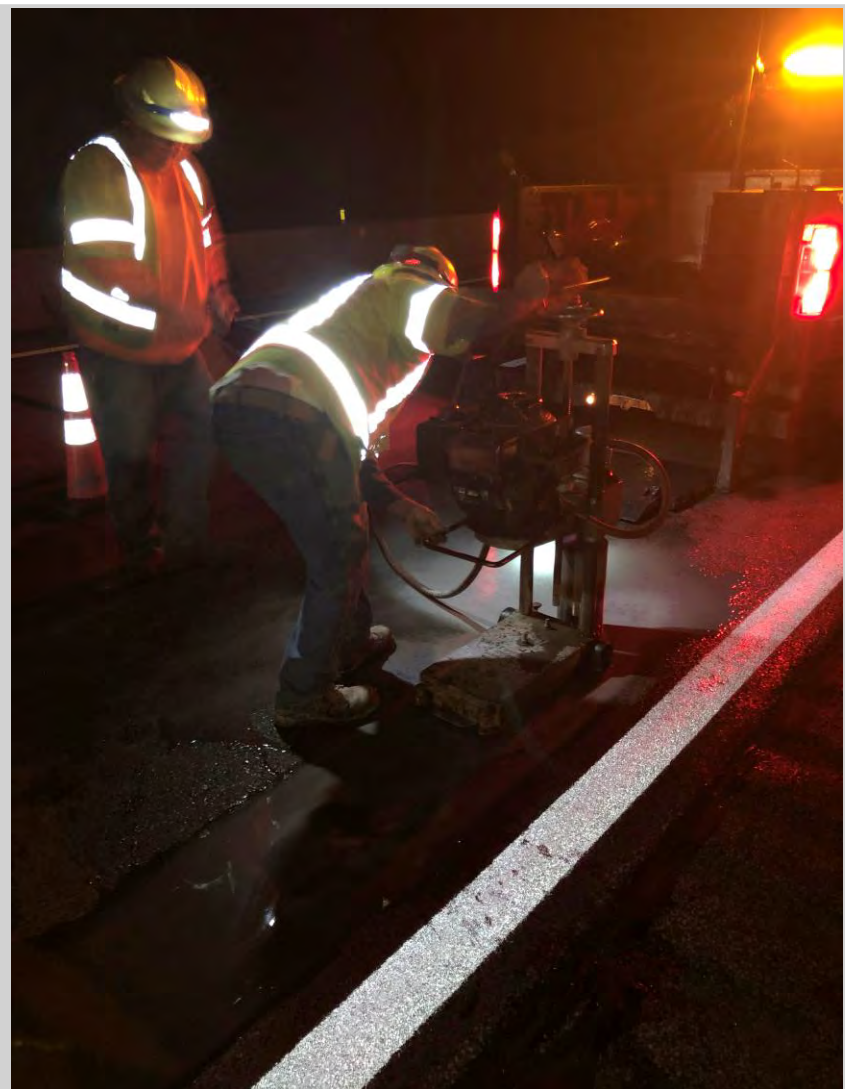
Roadway Core Review

Right Wheel Path Core Example of Differing Bituminous Layers Center Lane Core

Distinct lines were highly visible between the 1973 binder and the 1973 leveling coarse within cores taken from the wheel paths. However, Core specimens extracted from the center of the lane lacked this distinction. Observations of these two layers had provided a preliminary theory that the rutting may have been precipitated by the failure of these materials.

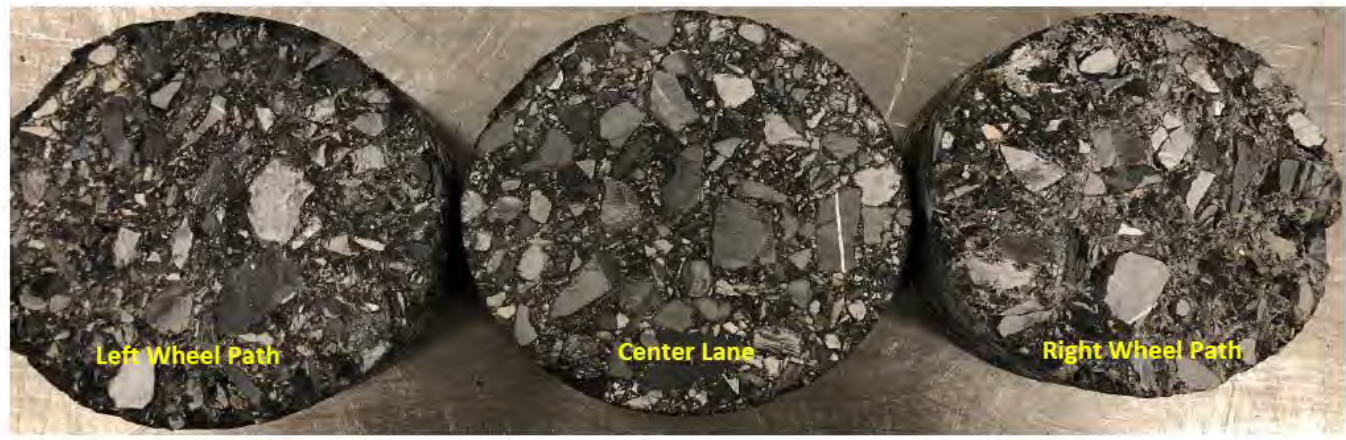
Severe rutting had taken place at mile post 144.08. Specimens obtained from this area had exhibited great amounts of aggregate breakage within the wheel paths along with lower bulk gravities. The significant amounts of aggregate breakage had created additional air void volume within the specimens, therefore lowering the bulk gravity.

Crushed Aggregate in Binder Coarse

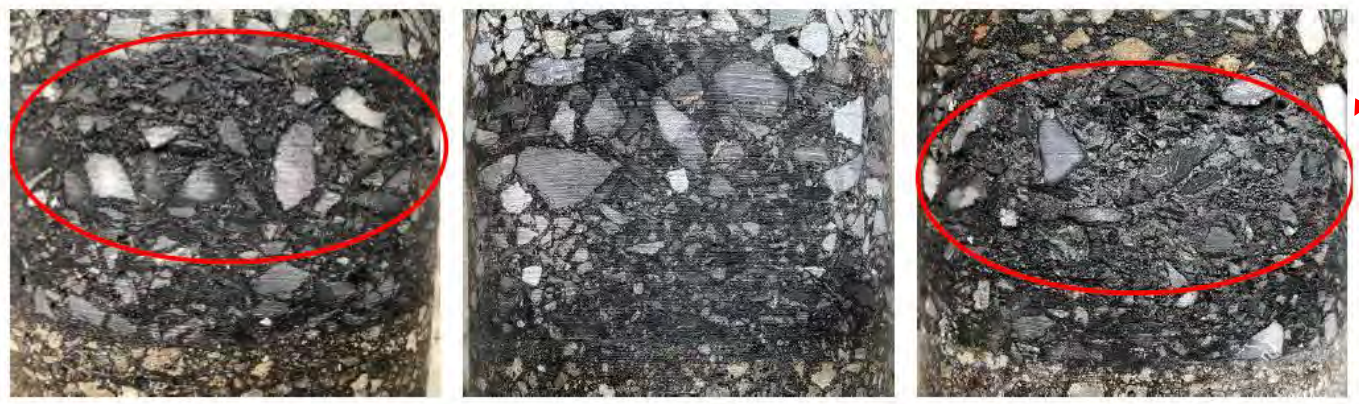
Crushed Aggregate in Binder Coarse

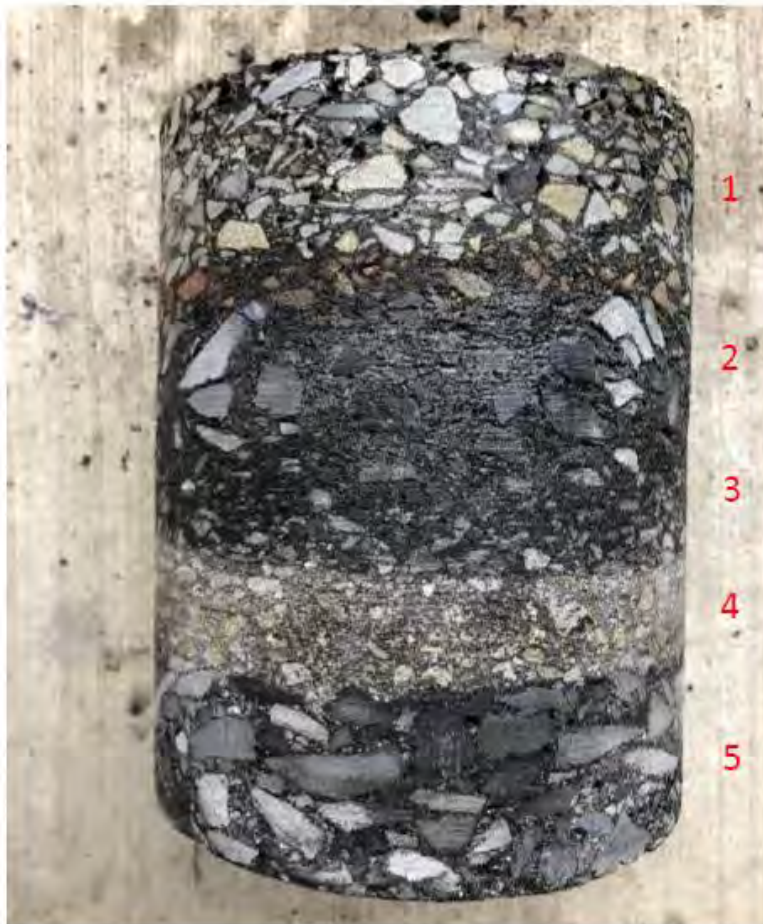
Asphalt Lift Conditions

5 Bituminous coarse were identified

Condition

1.) 9.5mm (2013) & 12.5mm (2020)
Calcareous Sandstone

Good

2.) 19mm binder coarse (1973)
Limestone

Poor

3.) Leveling coarse (1973)
Limestone

4.) ID2 wearing coarse (1953)
Blast Furnace Slag

5.) ID3 binder coarse (1953)
Limestone

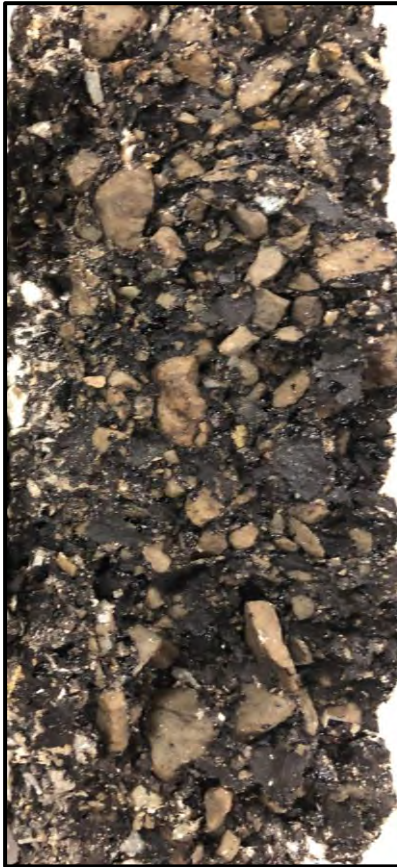
Severe Stripping Observed in Field Cores

Age	9 yrs.
Pbe	4.8%
TSR	83.2
CT Index	65

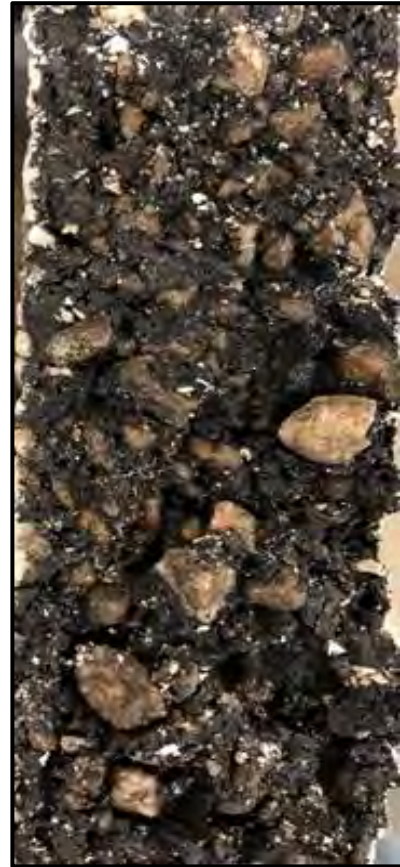
Age	5 yrs.
Pbe	5.2%
TSR	94.6
CT Index	112

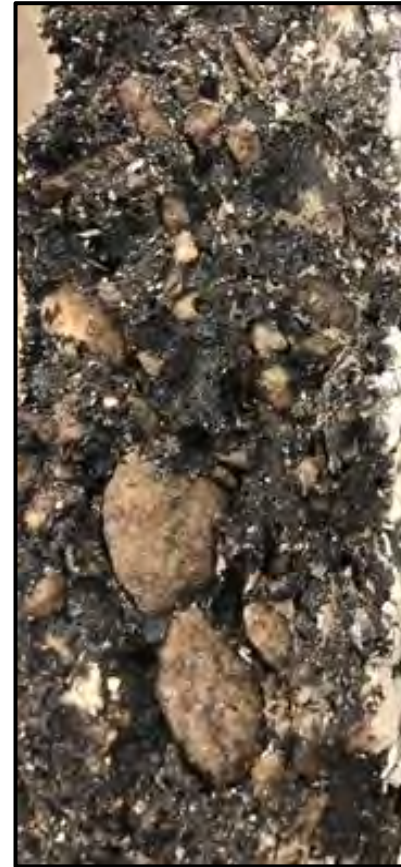
Age	4 yrs.
Pbe	5.3%
TSR	100.5
CT Index	79

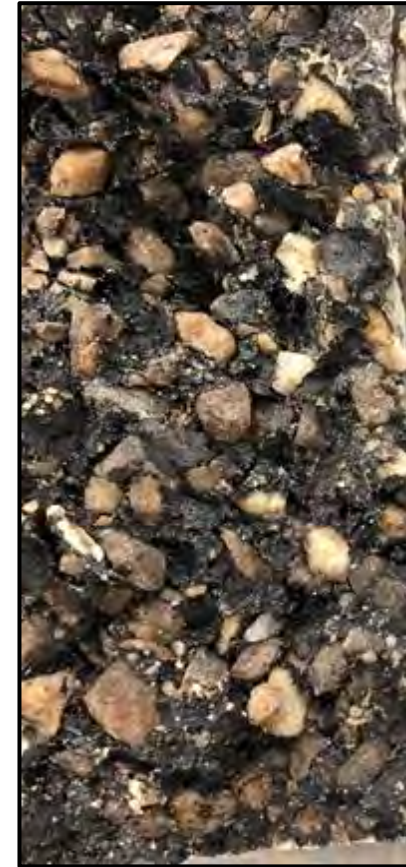
Age	3 yrs.
Pbe	6.5%
TSR	98.5
CT Index	832
