NJDOT's Strategy for Rehabilitation of Composite Pavements

Thomas Bennert, Ph.D.
Center for Advanced Infrastructure and Transportation
(CAIT)
Rutgers University

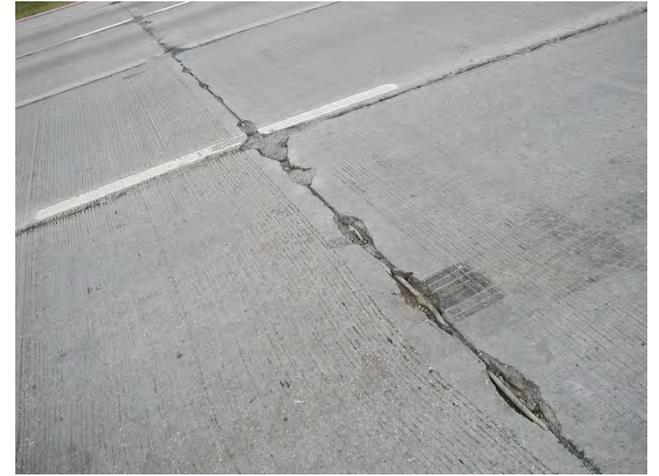
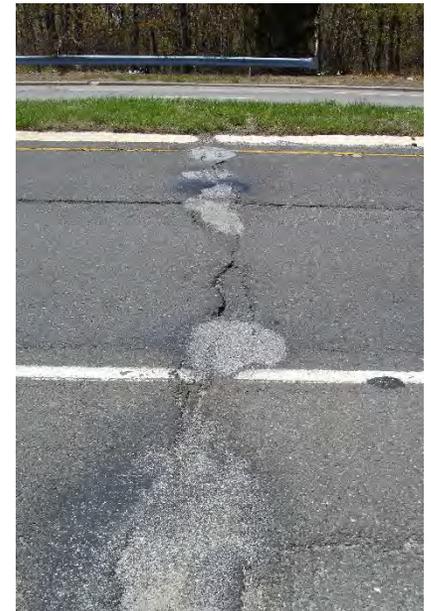
- Reflective Cracking – the type of fatigue cracking generally witnessed when a crack in an asphalt overlay is generated immediately above the longitudinal joint and/or crack in the underlying PCC pavement
- Different loading mechanisms (or combination of) can cause reflective cracking
 - Mode 1 – Excessive Vertical Bending at PCC joint/crack (Pure Tensile Straining)
 - Mode 2 – Horizontal Deflections (PCC slab expansion and contraction) due to environmental cycling
 - Mode 3 – Poor Load Transfer at joint/crack results in independent movement of PCC slabs

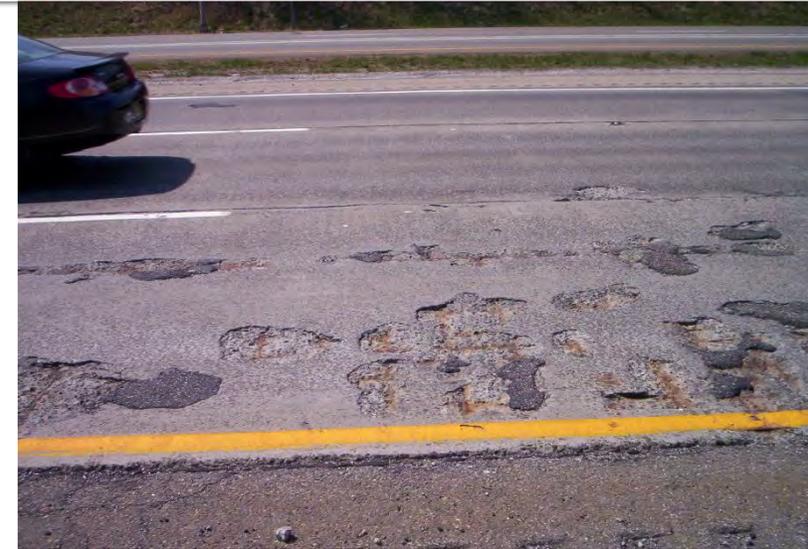
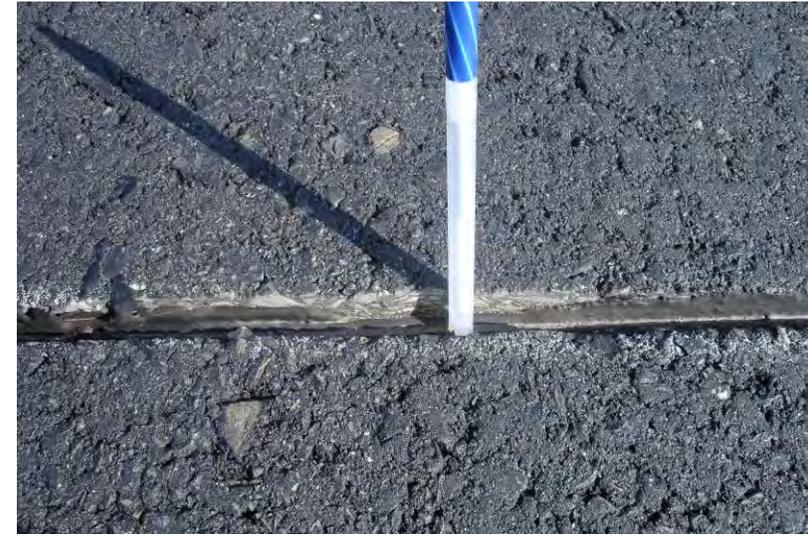
NJDOT's "Conditions"

- Most constructed PCC pavements
 - Length = 78'2" ft (25 m)
 - Width = 12'; Thickness = 9 inches
 - $\frac{3}{4}$ " expansion joints with $1\frac{1}{4}$ " steel dowels
- If 1st generation HMA overlay, saw and seal conducted
 - Attempts to saw & seal 2nd generation overlays difficult in finding joints
 - Generally poor construction practices

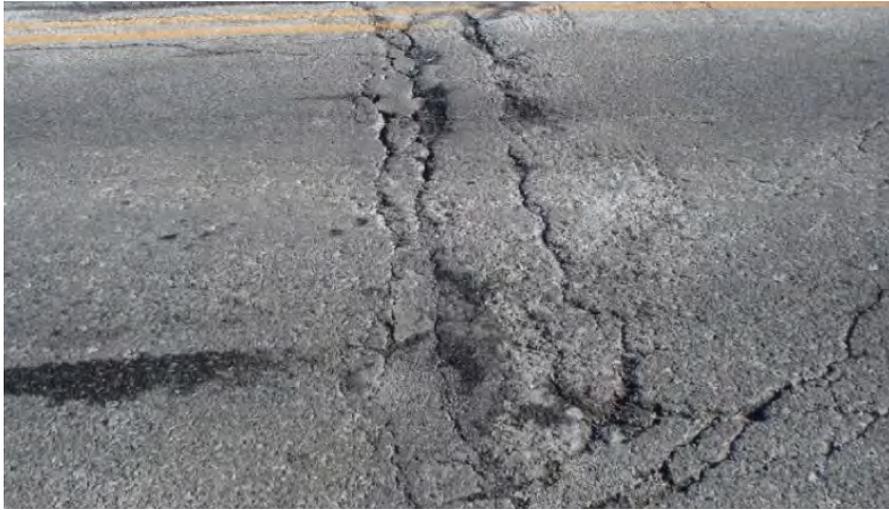
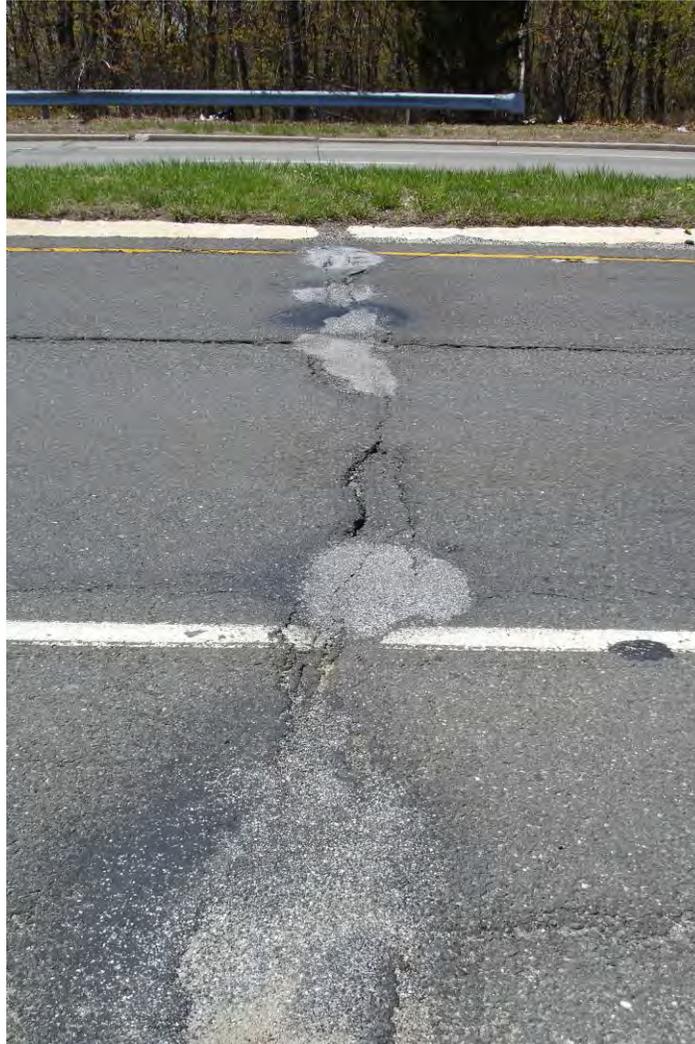
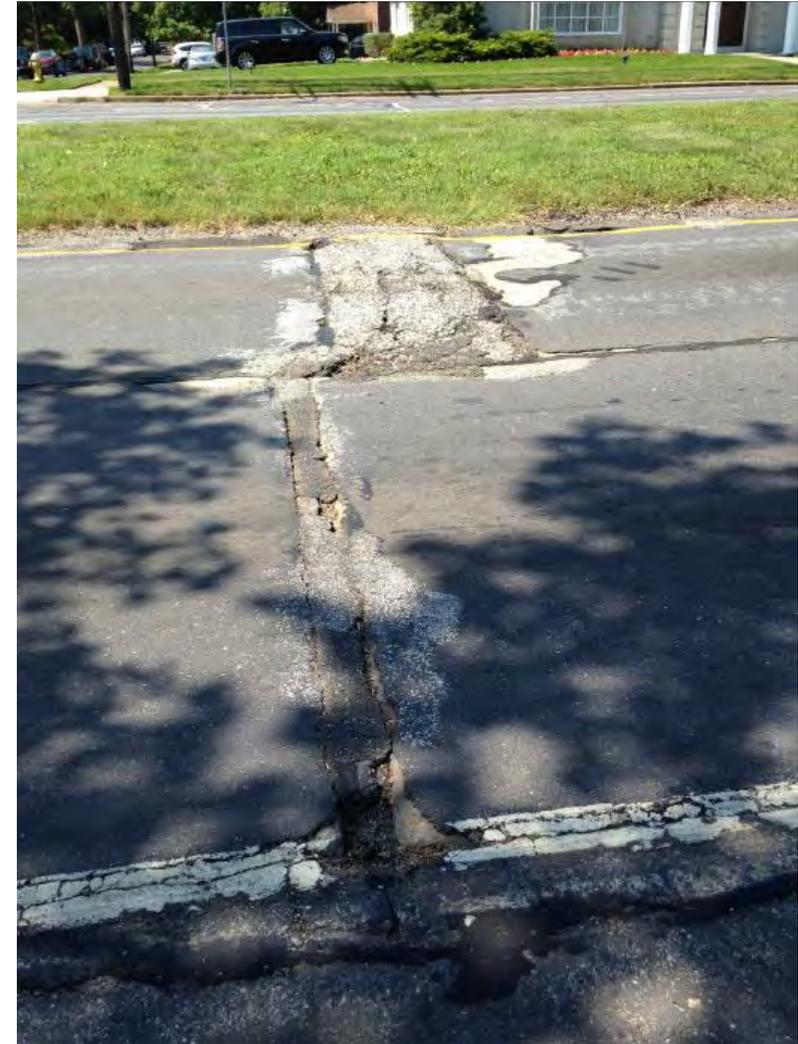
NJDOT Rehabilitation Efforts Prior to 2006

- During this time, NJDOT attempted to look at “alternatives”
- Rt 10 Reflective Crack Relief Interlayer
- Rt 1 Paving Fabric
 - No cracking in fabric section in Yr 1
 - All sections cracked equally in Yr 2

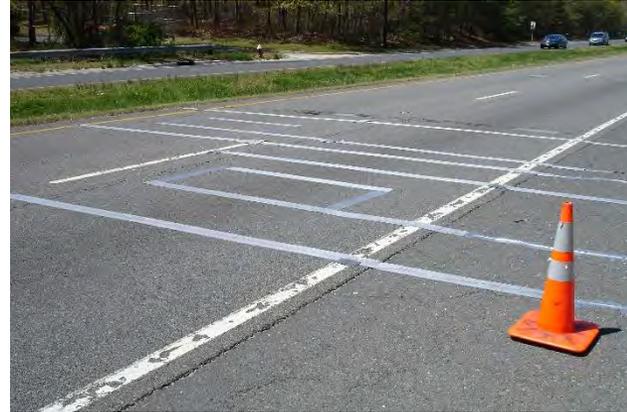
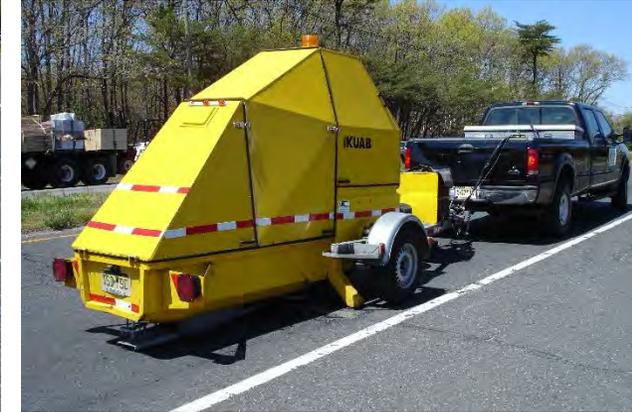
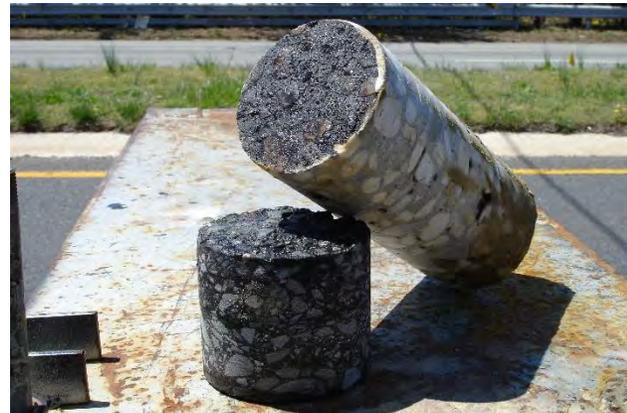
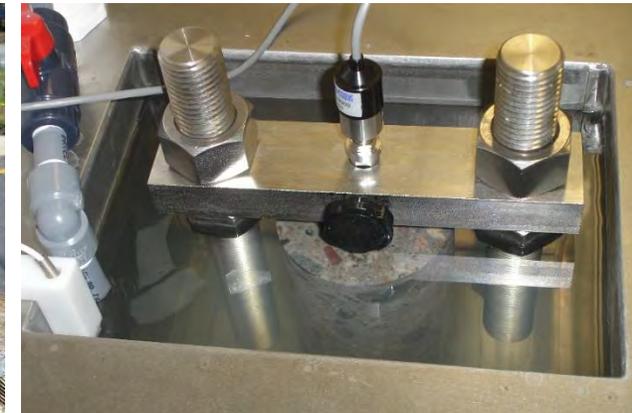
NJDOT/Rutgers Field Research Sections

- 2007 to 2010 looked at a number of field sections
 - Interlayers
 - Different HMA designs (AC%, binder grades)
 - Portable WIM's for traffic
 - FWD at joints/cracks
 - Field cores of PCC for Coefficient of Thermal Expansion (CTE)
- Results allowed for the development of a ***design/selection methodology based on the measured performance of asphalt mixtures***

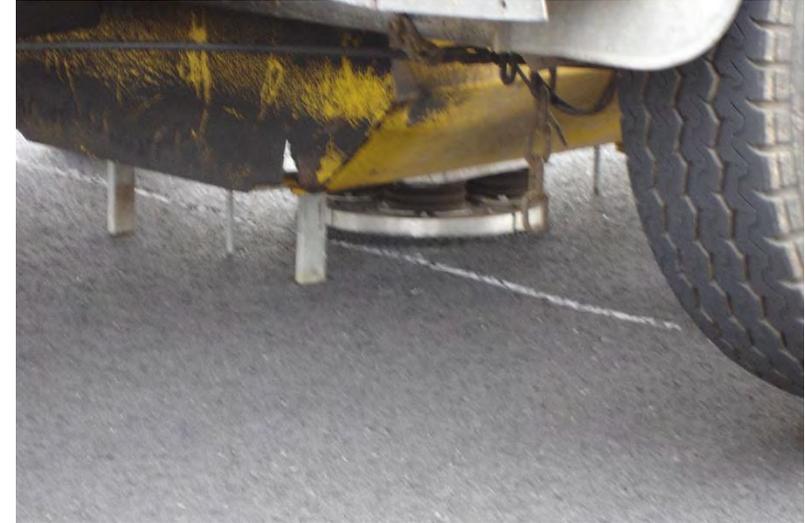
Evaluating Material Properties for Composite Pavement Design - Mode 1

- The vertical deflection at the PCC joint/crack is a function of the applied axle load
- Magnitude of vertical deflection can be evaluated using Falling Weight Deflectometer (FWD) at different loads
- Combined with measured traffic/axle loading, a “Deflection Spectra” can be developed specifically for the pavement

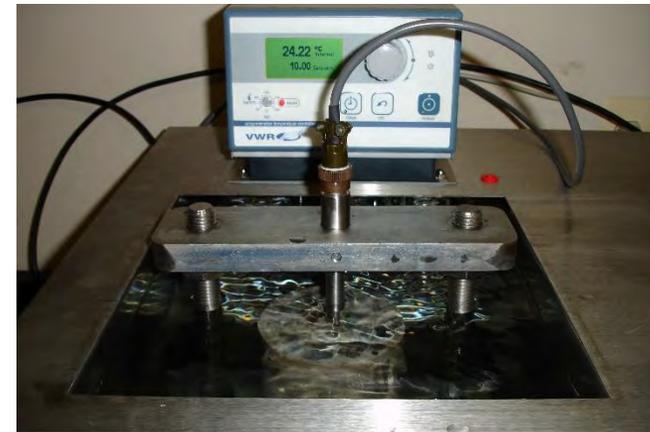
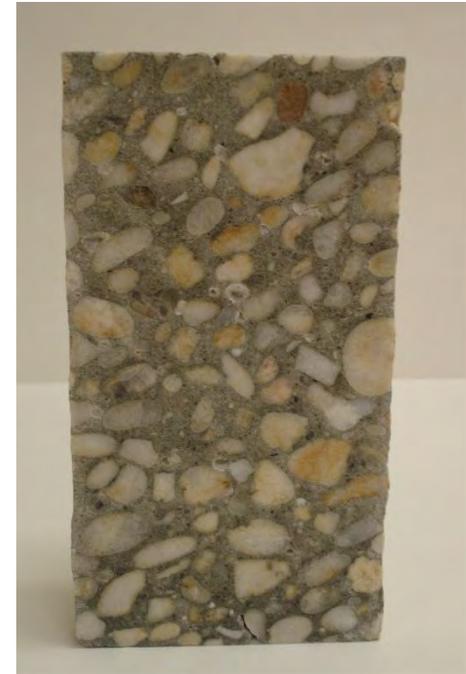
NJ Rt 34N PCC:

- 40 ft slabs
- Measured CTE of Cores = 12.34E-6 in/in/°C

- Based on 4.5” HMA Overlay on PCC

- Used EICM to predict temp profile and took maximum based on 2002 and 2003 data

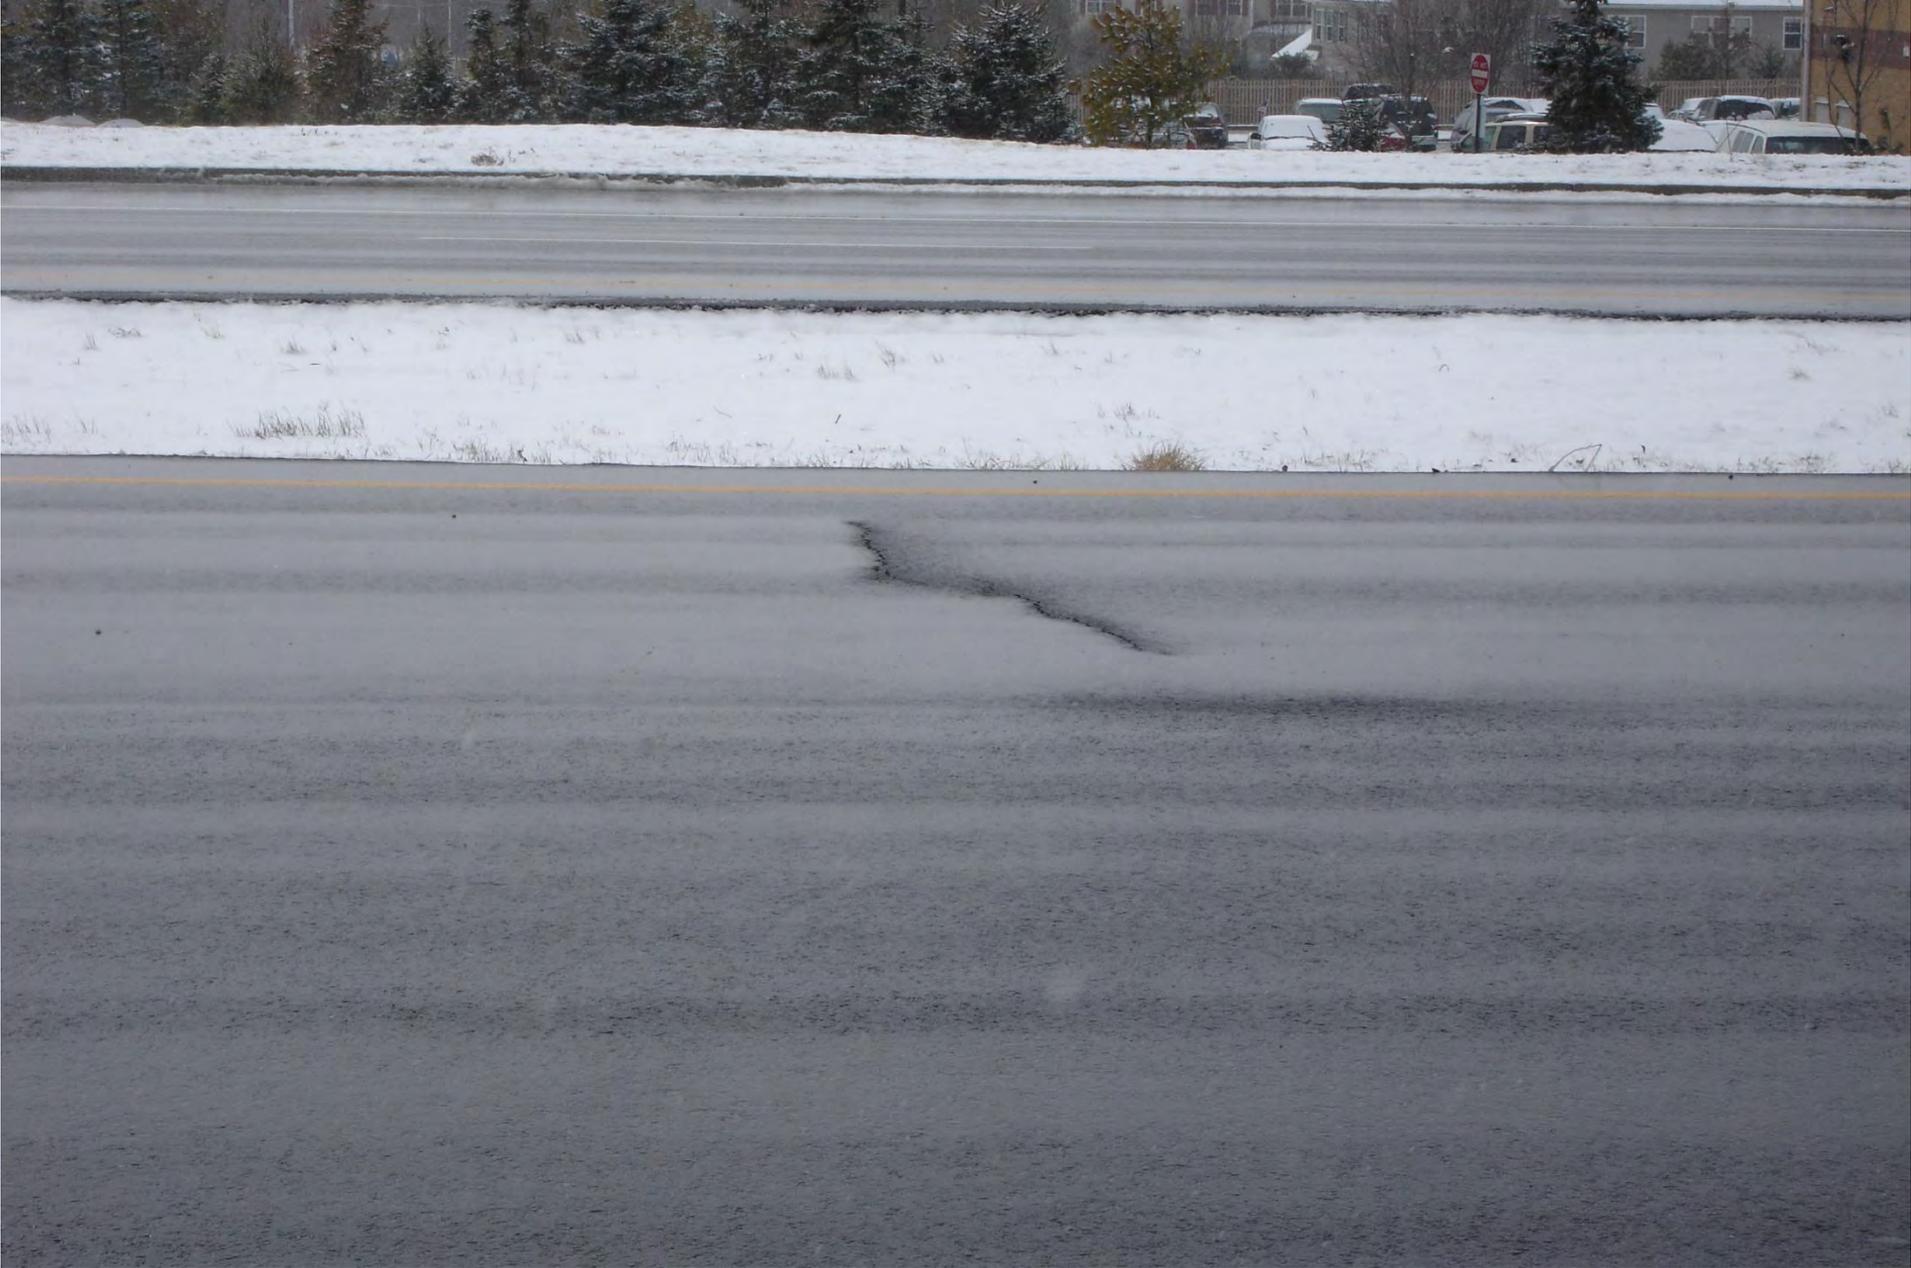
Rt 34N - MP 0.3
Just North of Traffic Light

March 2007
(5 Months After Construction)

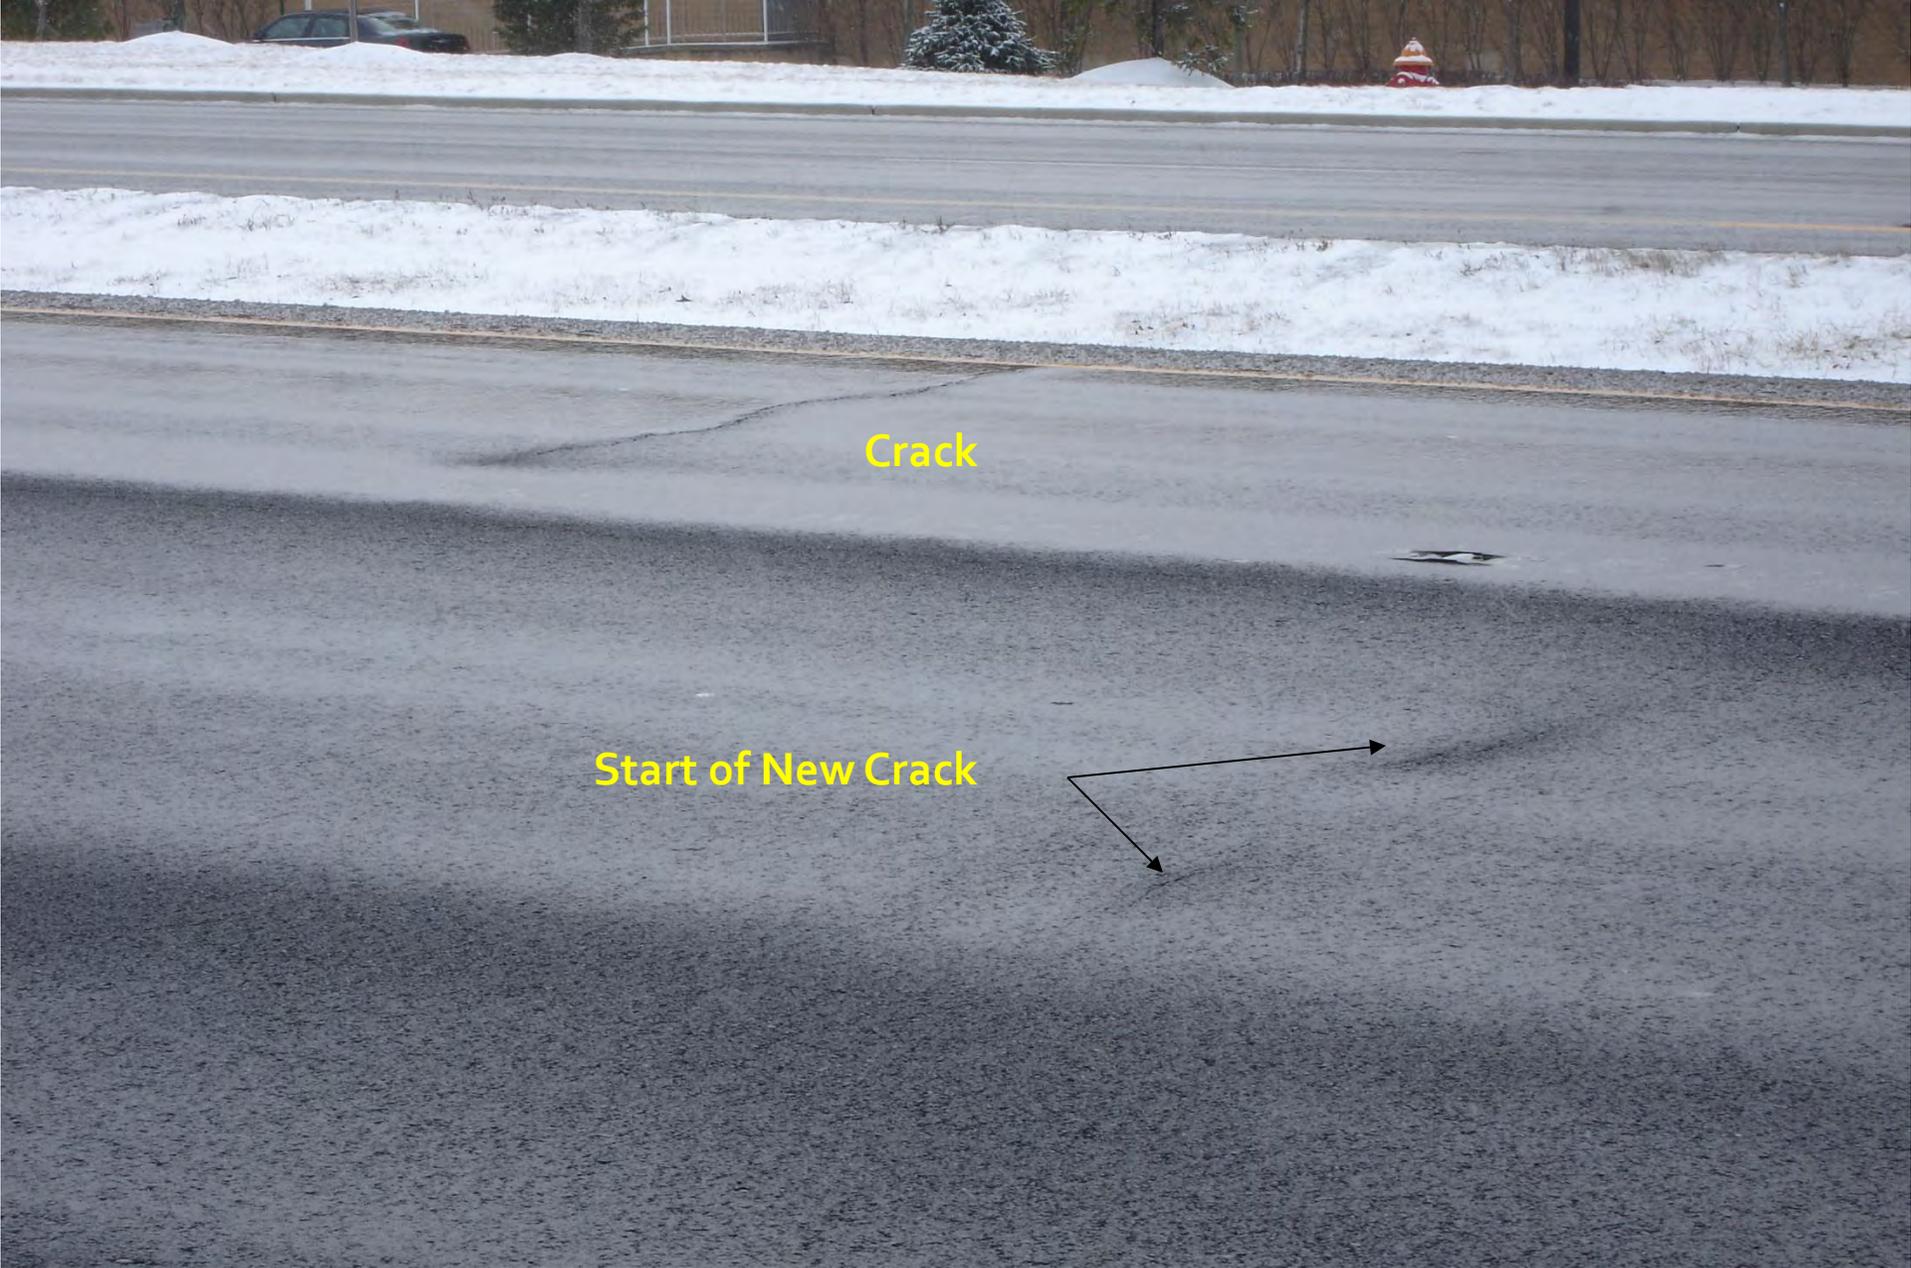
Rt 34N - MP 0.35
In front of Investors Bank

March 2007
(5 Months After Construction)

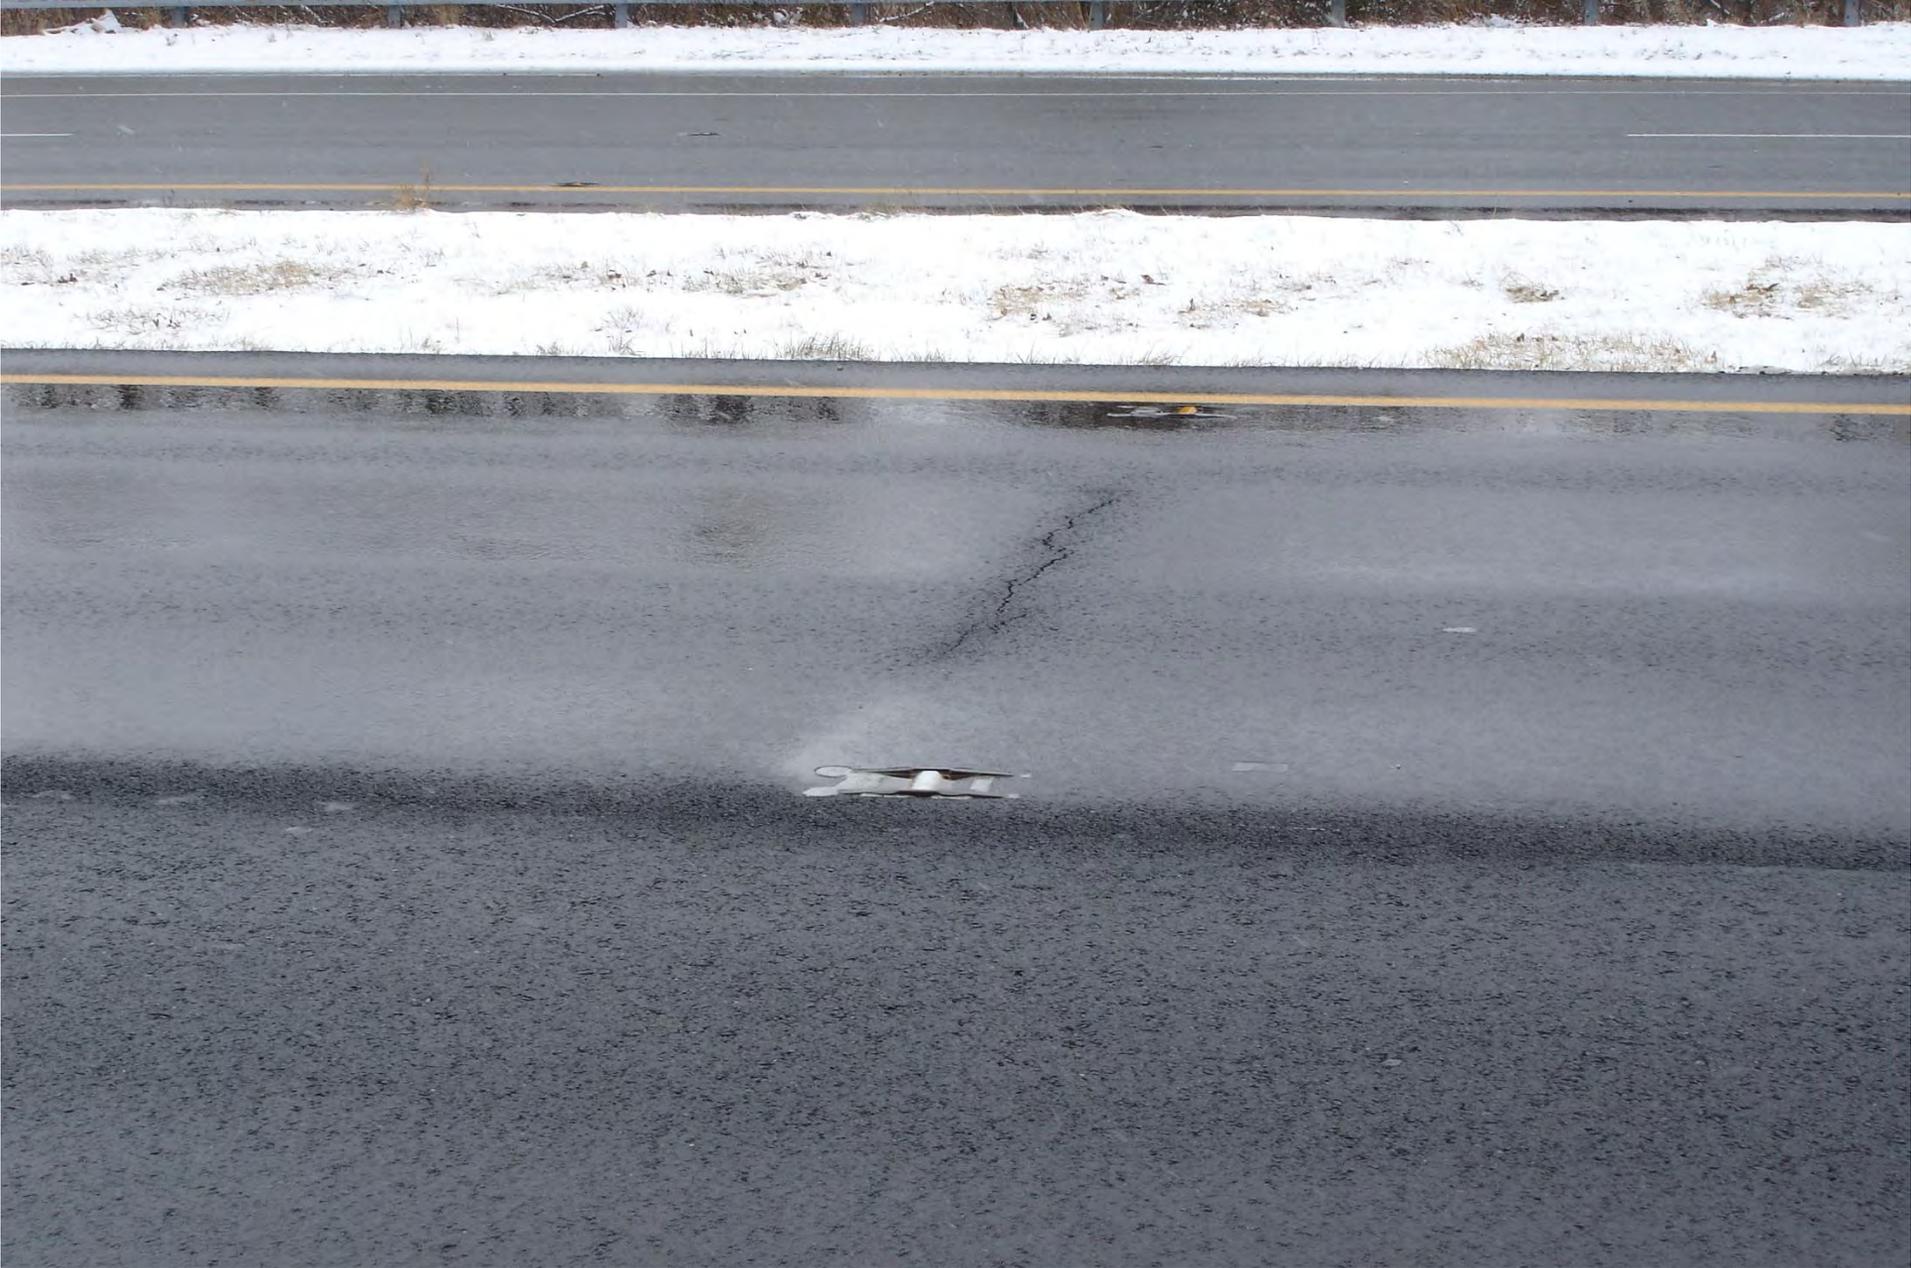
Rt 34N - MP 0.35
In front of Harbor Lights

March 2007
(5 Months After Construction)

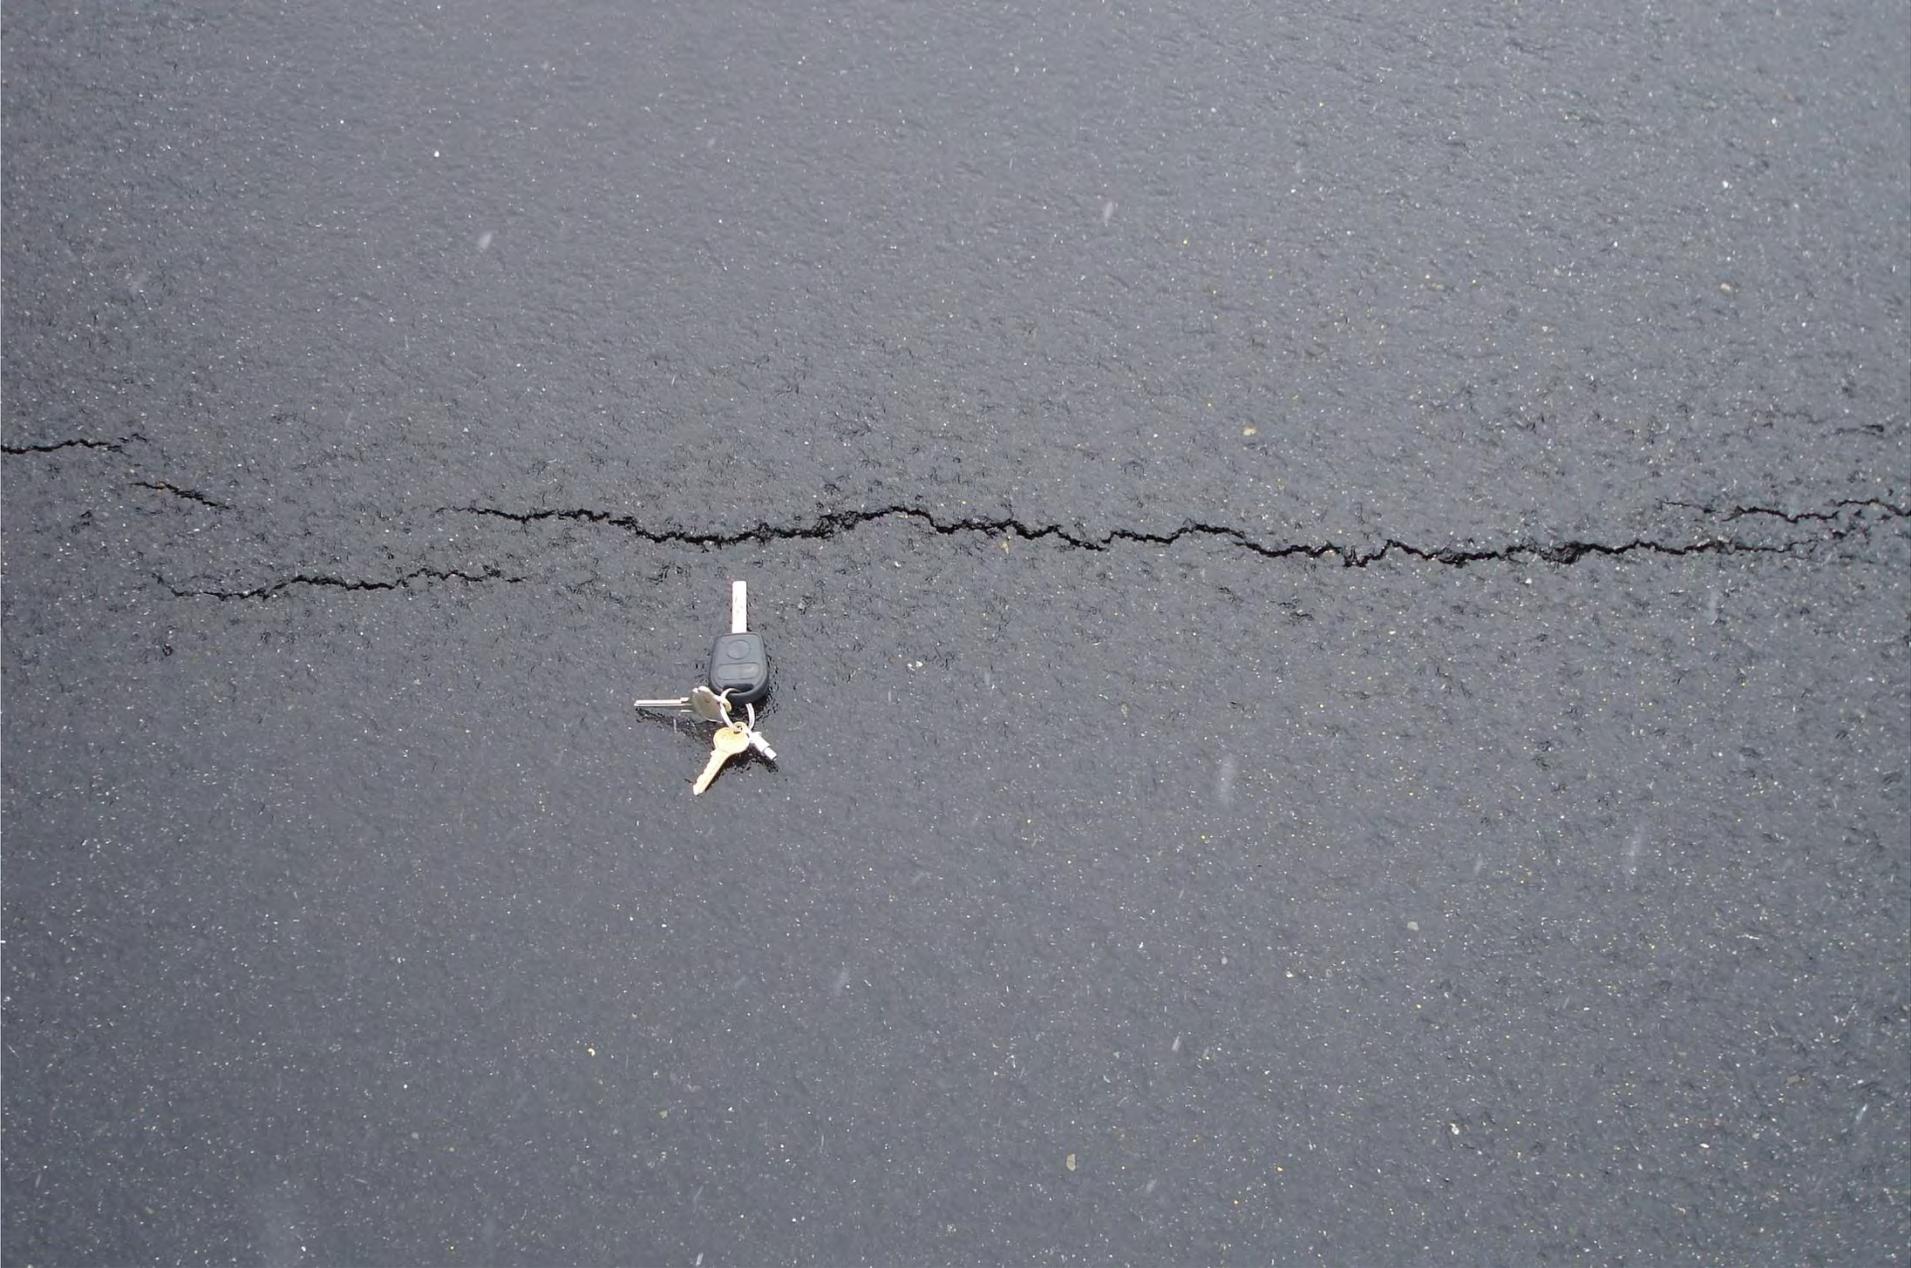
Rt 34N - MP 0.35
Close-up of Crack by Harbor Lights

March 2007
(5 Months After Construction)

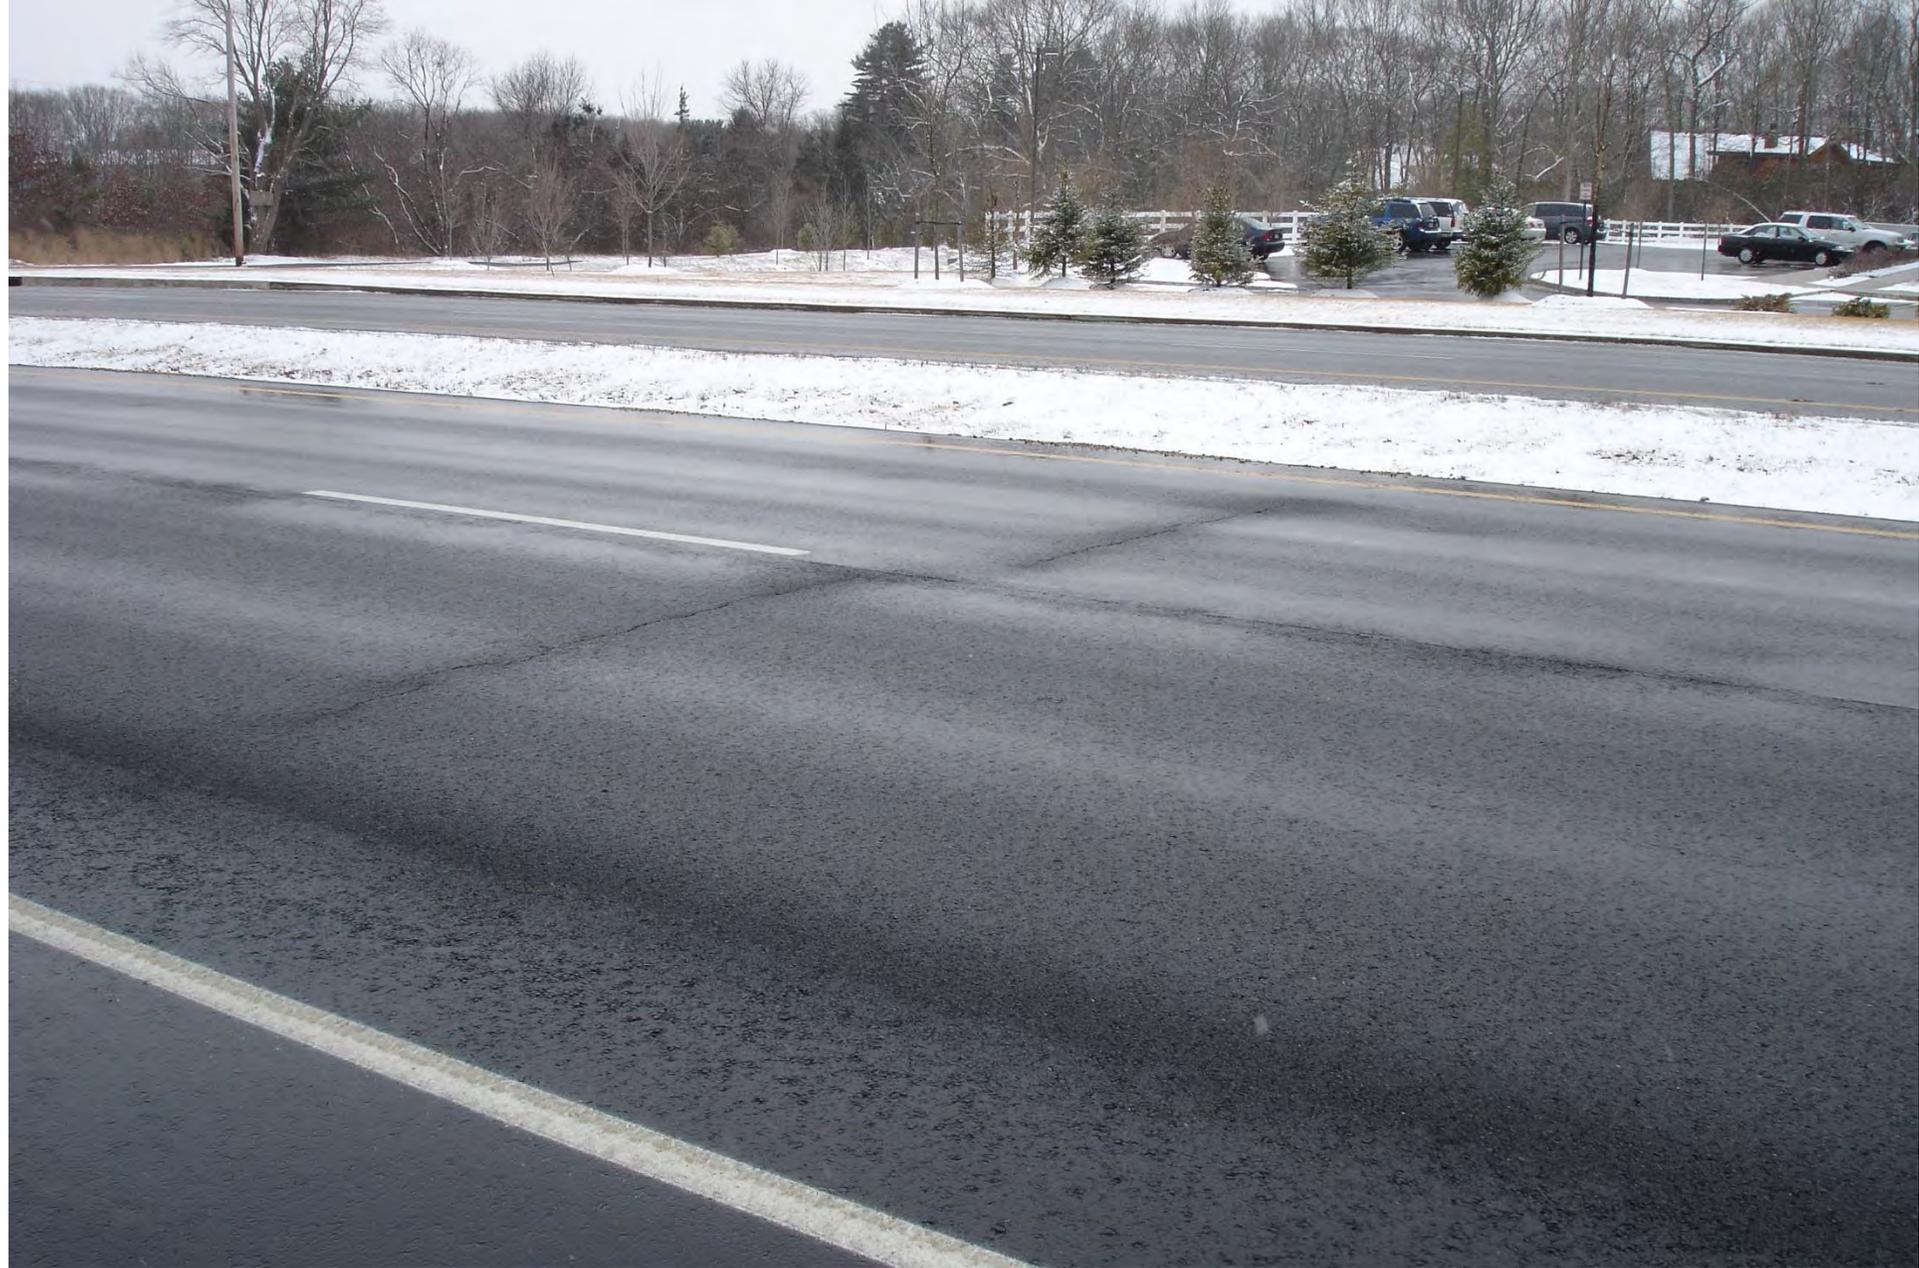
**Rt 34N - MP 0.45
Just North of Hully Plaza**

**March 2007
(5 Months After Construction)**

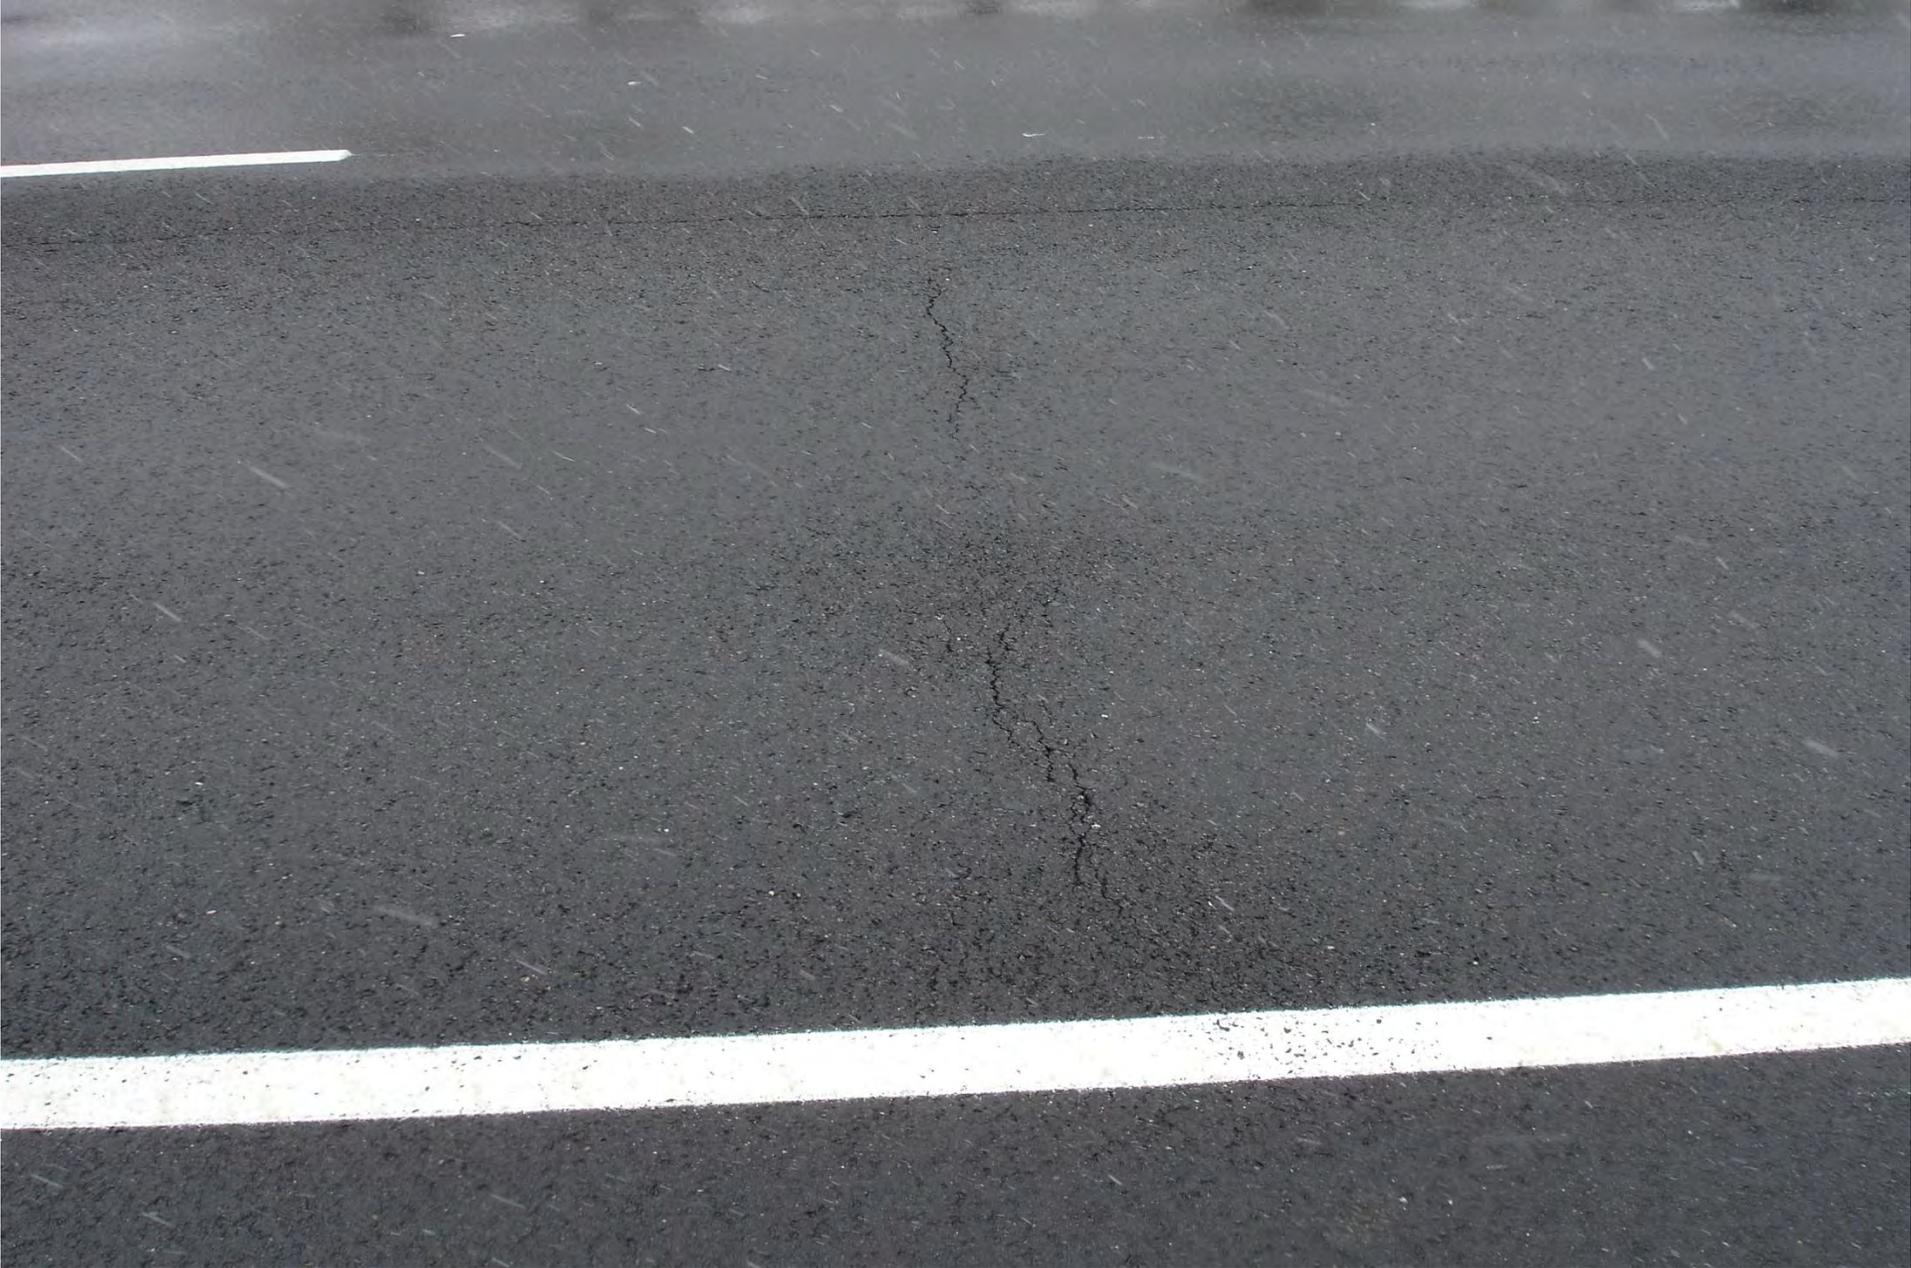
Rt 34 N - MP 7.0

**March 2007
(5 Months After Construction)**

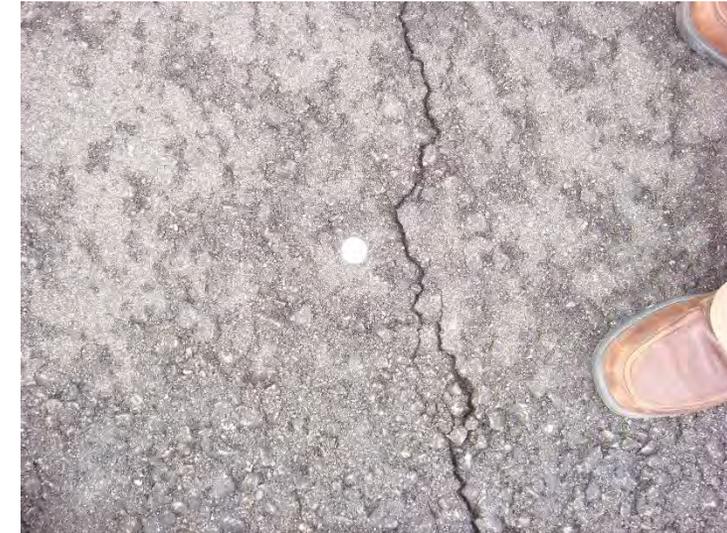
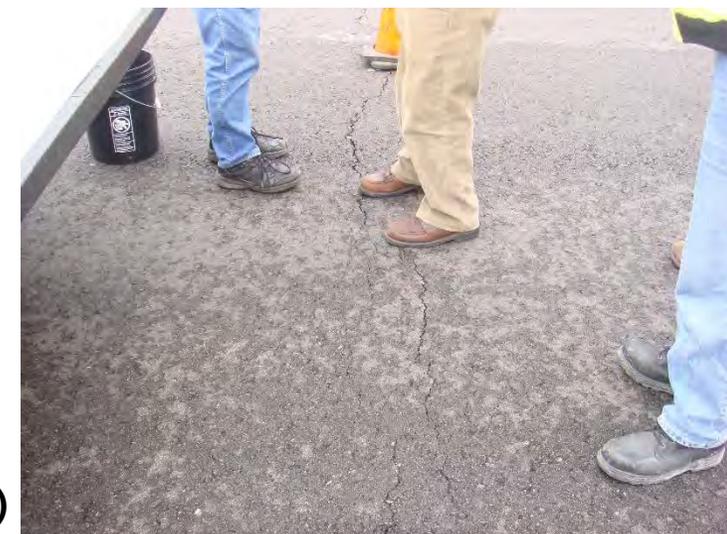
(Worden, 2008)

- Material selection!
 - Interlayers work but still need good overlays!
 - Composite pavement design needs to be thought of as a “system approach”
 - Asphalt immediately over PCC needs to be able to withstand horizontal and vertical deflection
 - Surface course must still be able to withstand vertical deformation
 - Compatibility is required between asphalt materials – can not have very flexible overlaid by very stiff
 - Example: Massachusetts I495

- Material selection!
 - “Crack jumping” on MA 1495
 - Interlayer worked, leveling course and intermediate layer cracked with 7 months of paving!
 - Too stiff to withstand horizontal deflections (leveling course) and residual vertical deflections (intermediate course)
 - Stress Absorbing Membrane Interlayers (SAMI's)
 - Is this term misleading?
