NJDOT's Strategy for Rehabilitation of Composite Pavements

Thomas Bennert, Ph.D.
Center for Advanced Infrastructure and Transportation
(CAIT)
Rutgers University

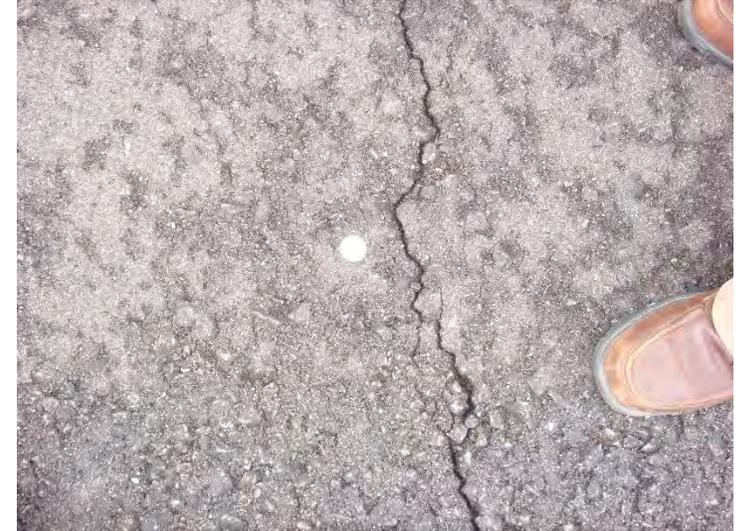
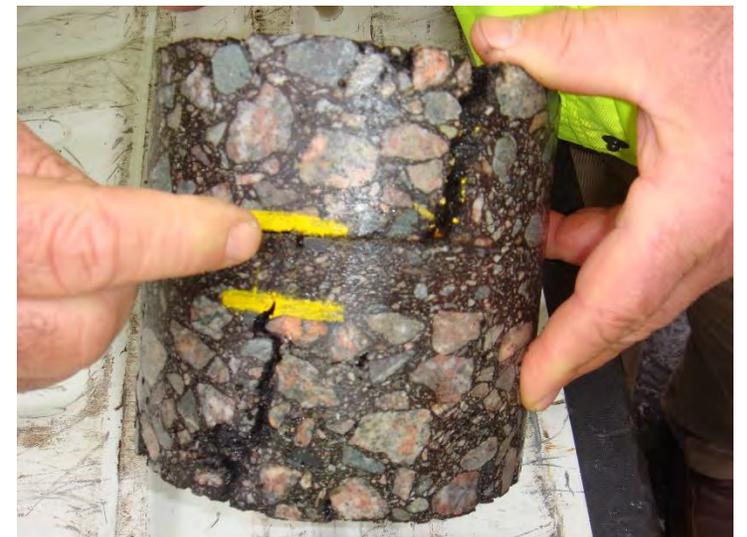
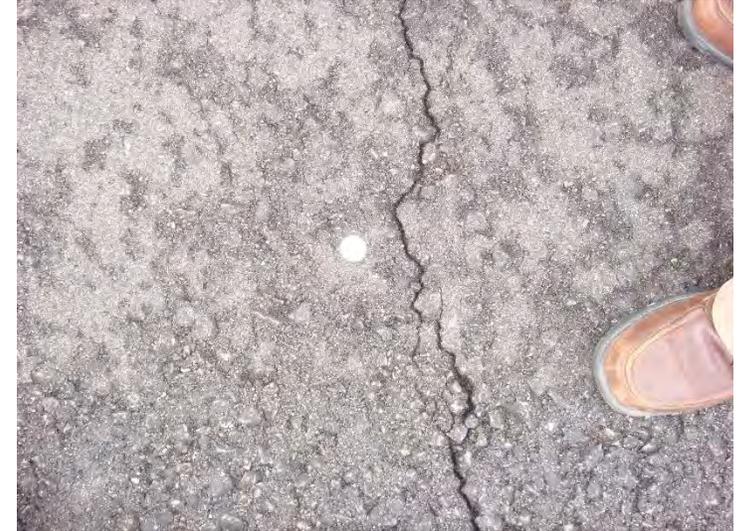
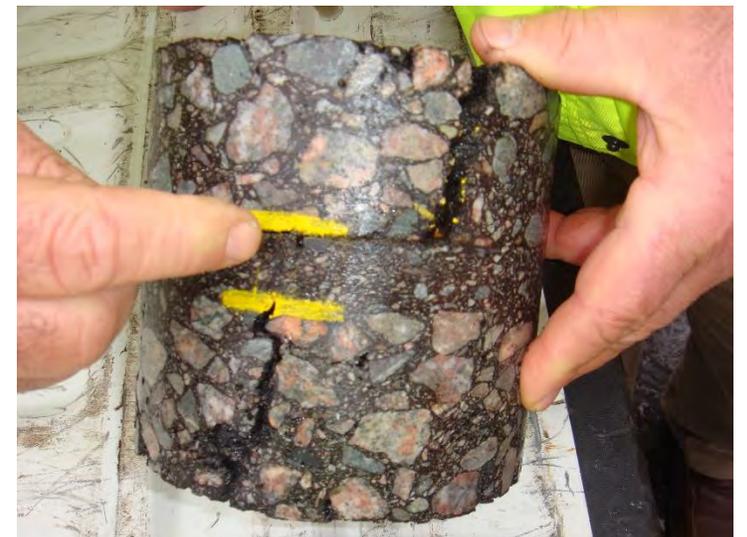
- Material selection!
 - “Crack jumping” on MA 1495
 - Interlayer worked, leveling course and intermediate layer cracked with 7 months of paving!
 - Too stiff to withstand horizontal deflections (leveling course) and residual vertical deflections (intermediate course)
 - Stress Absorbing Membrane Interlayers (SAMI's)
 - Is this term misleading?

- Material selection!
 - “Crack jumping” on MA 1495
 - Interlayer worked, leveling course and intermediate layer cracked with 7 months of paving!
 - Too stiff to withstand horizontal deflections (leveling course) and residual vertical deflections (intermediate course)
 - Stress Absorbing ~~Interlayers~~ Interlayers (SAMI's)
 - Strain Tolerant Asphalt Materials (STAM's)

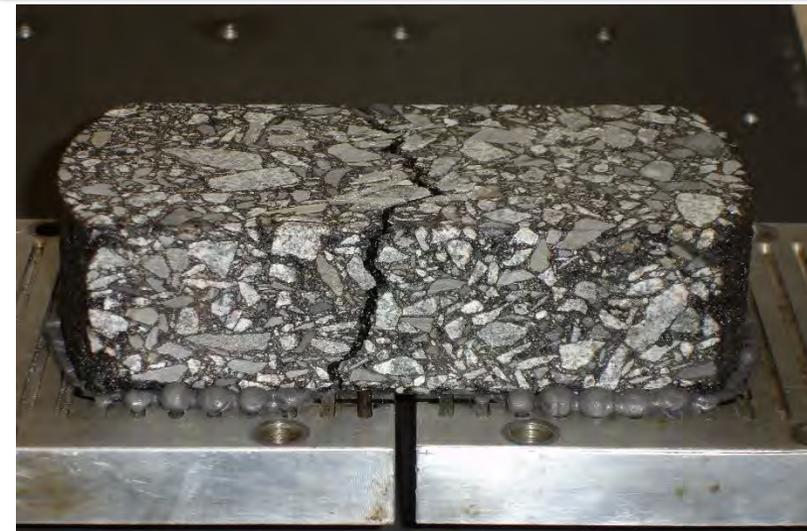
5 Cycles (0 inches)

**0.035" Opening
15°C (59°F)**

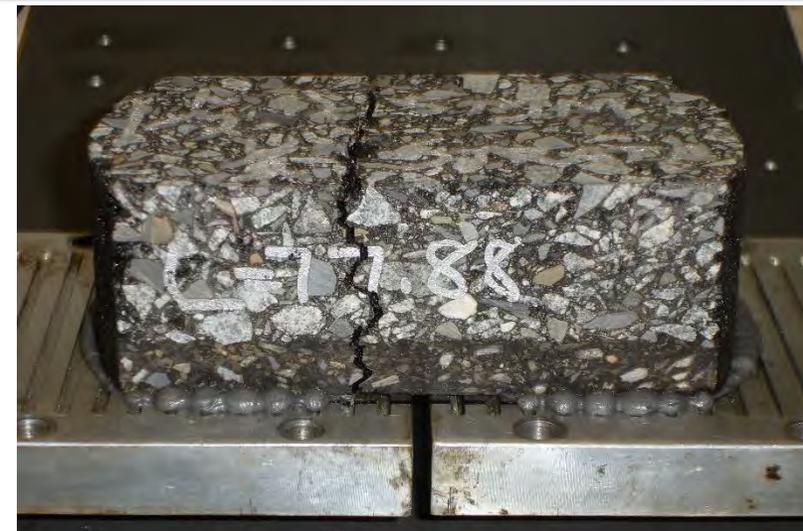
278 Cycles (0.5 inches)

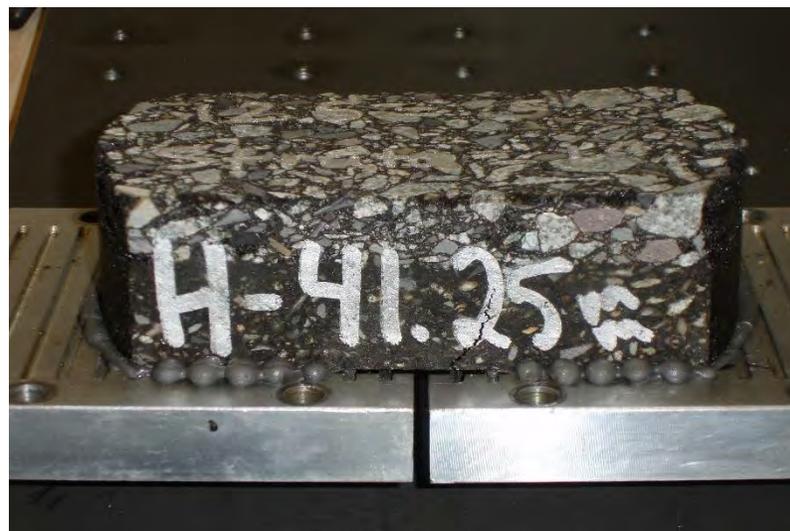
>2,800 Cycles (1.0 inches)

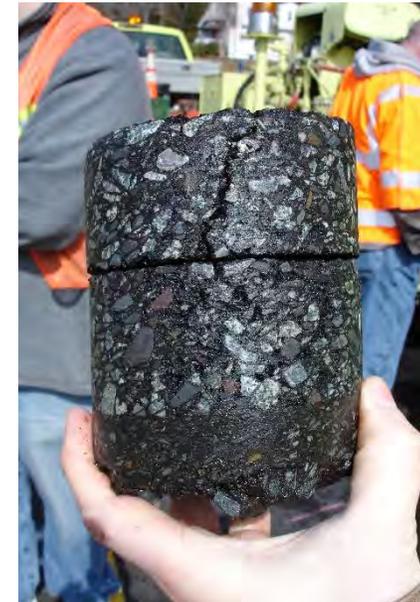
NJDOT/Rutgers Field Research Sections – Lessons Learned - Bonding of Asphalt Layers

- Proper tack coat/bond strength
 - Composite pavements have high vertical deflections at PCC joints/crack
 - Important to ensure good bonding to properly distribute stress
 - If unbonded, surface lift will take majority of applied stress and bottom-up cracking will occur in that lift solely

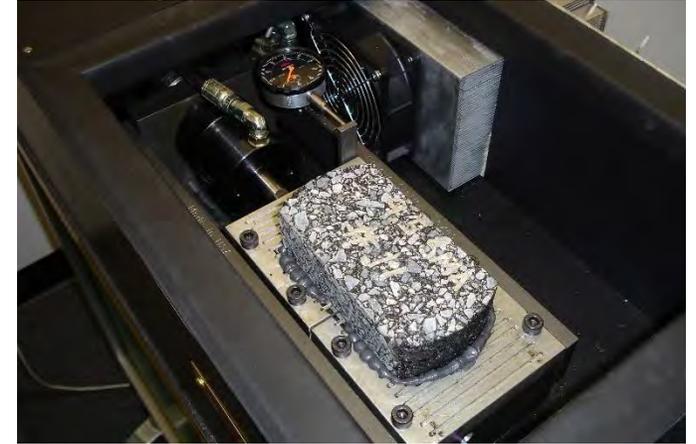
- Assumptions
 - Good construction and not using excessive overlay thickness (EOT)
- Step 1: Find material to withstand expected horizontal deflections (Mode 2)
 - Analysis found this to be controlling factor
 - Developed Bituminous Rich Intermediate Course (BRIC)
 - Originally required PG70-28
 - Currently have Overlay Tester as performance criteria for cracking

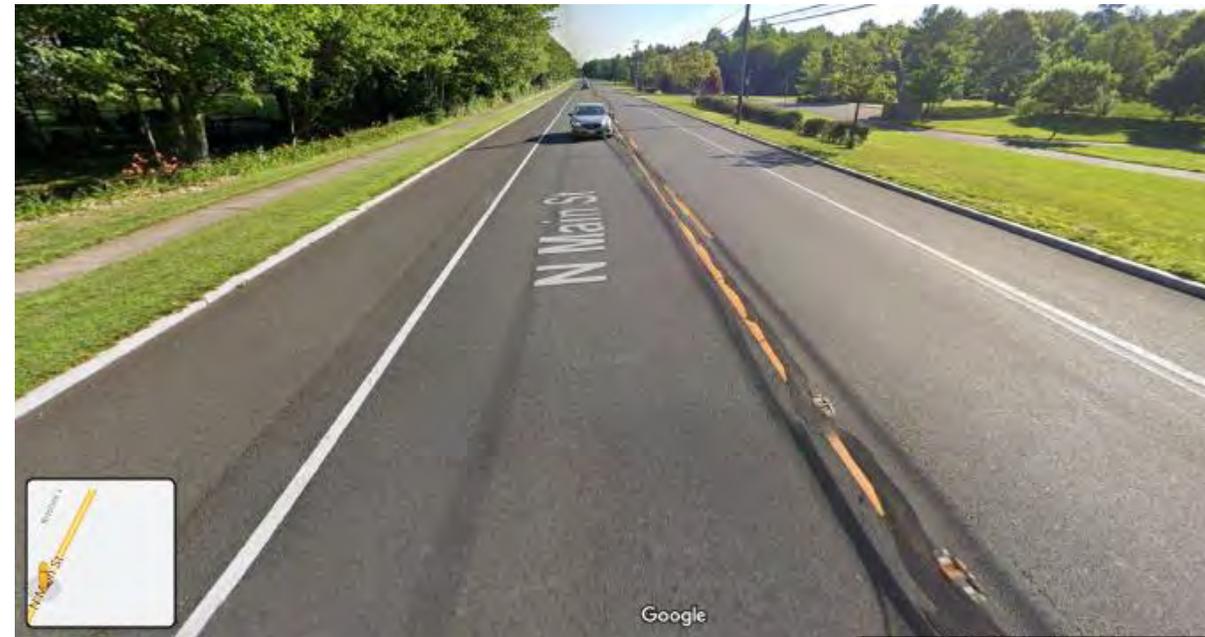
Examples: Rt 9 – Ocean County

- 20 year ESAL's = 5 million
- Existing 2-3" HMA over 8" JRCP
 - Built 1920's with 50' joint spacing
 - SDI = 2.1; IRI = 222 in/mile
- Resurface in 2011
 - Mill 3"
 - 2" SMA over 1" BRIC
 - SDI = 5.0; IRI = 78 in/mile
- 2020 PMS Data
 - SDI = 4.6; IRI = 83 in/mile

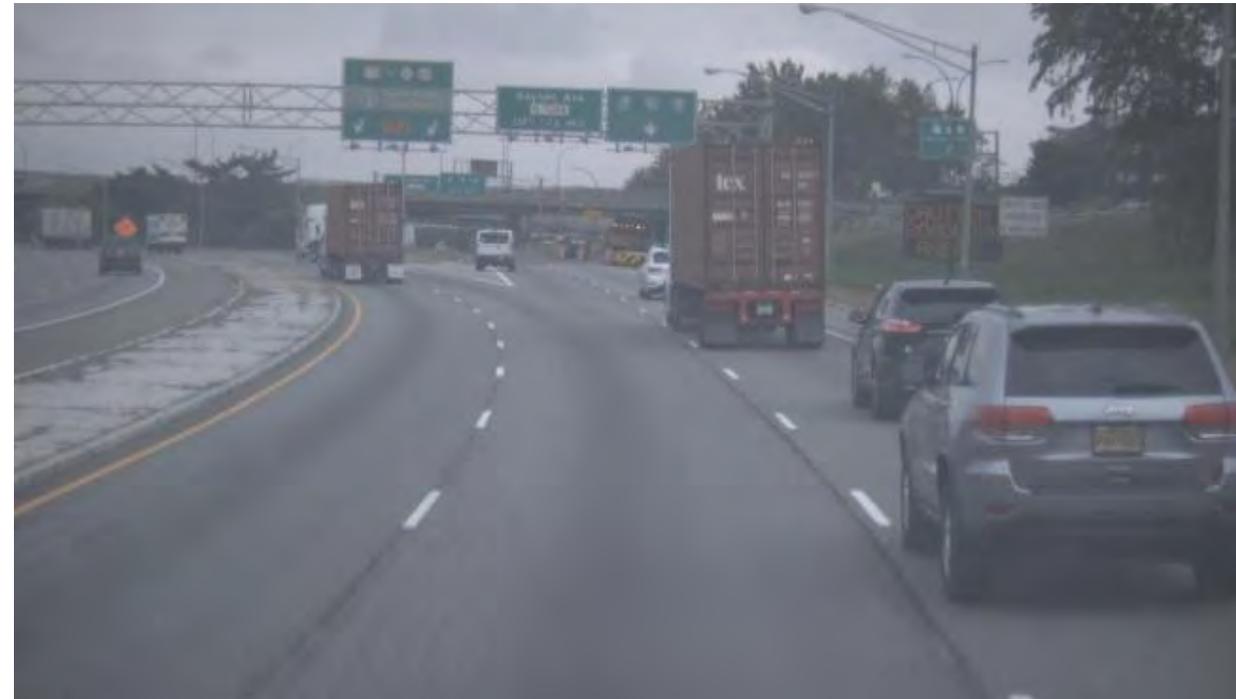
Examples: Rt 1 & 9 – Hudson County

- 20 year ESAL's = 80 million
- Existing 3-4" HMA over 10" JRCP
 - Built 1930/40's with 56' joint spacing
 - SDI = 0.67; IRI = 165 in/mile
- Resurface in 2011
 - Mill 3"
 - 2" SMA over 1" BRIC
 - SDI = 5.0; IRI = 59 in/mile
- 2020 PMS Data
 - SDI = 3.4; IRI = 93 in/mile

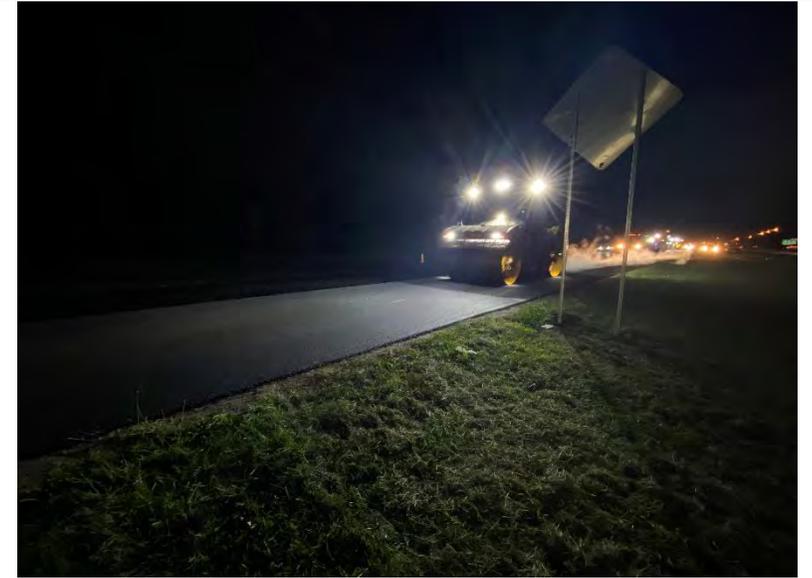
- Current;
 - Concrete good condition (0 – 10% repairs)
 - Small repairs and diamond grind for ride
 - Some slab stabilization if faulting identified
 - Concrete good condition (0 – 10% repairs)
 - 1" HPTO: low to moderate traffic, low risk
 - 1" HPTO over slurry seal: low to moderate traffic, moderate risk
 - 1" UHPTO over slurry seal: moderate to high traffic
 - Concrete fair condition (> 10% repairs)
