2021 PA Turnpike Accomplishments

Roadway Failures

Forensic Testing of Existing Roadway Structure

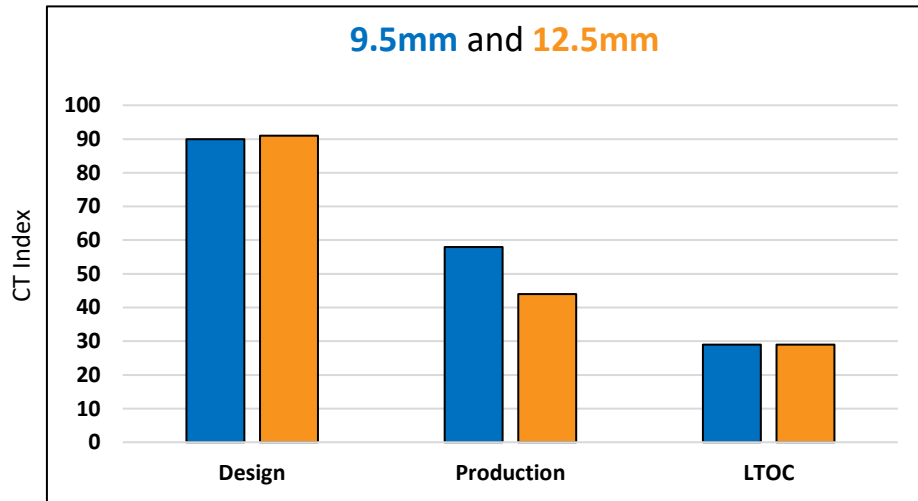
Establish a Baseline (Lab Samples)

1. Establish a baseline of CT Index values at various material stages (2018)
2. Observed significant differences between the various stages

Design		Prod.		LTOC	
	9.5	12.5	9.5	12.5	9.5	12.5
CT Index	90	91	58	44	29	29
St Dev	15.31	19.88	8.12	7.68	5.13	6.06
CoVar	16%	21%	14%	17%	19%	17%
Pbe	5.3	5.0	5.4	4.9	5.2	4.8

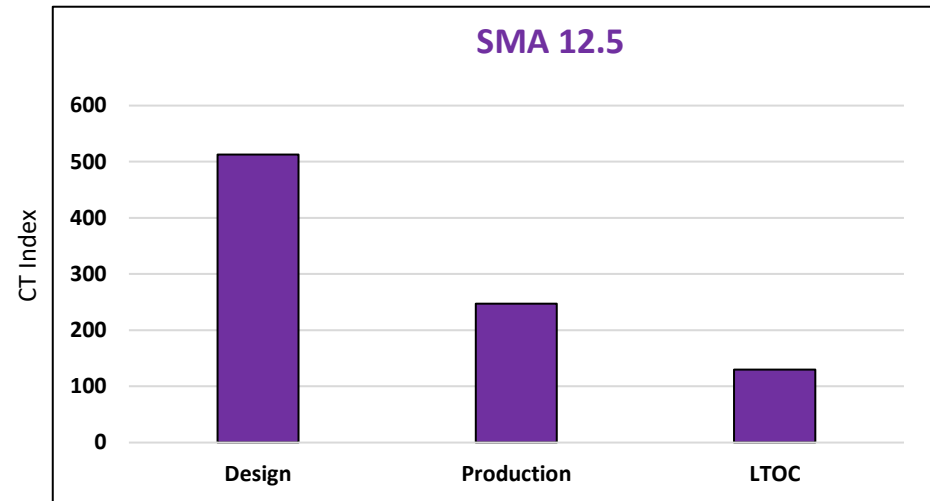
Design	Prod.	LTOC
	SMA	SMA	SMA
CT Index	513	247	130
St Dev	76.20	54.73	19.2
CoVar	15%	21%	13%
Pbe	6.5	6.3	6.4

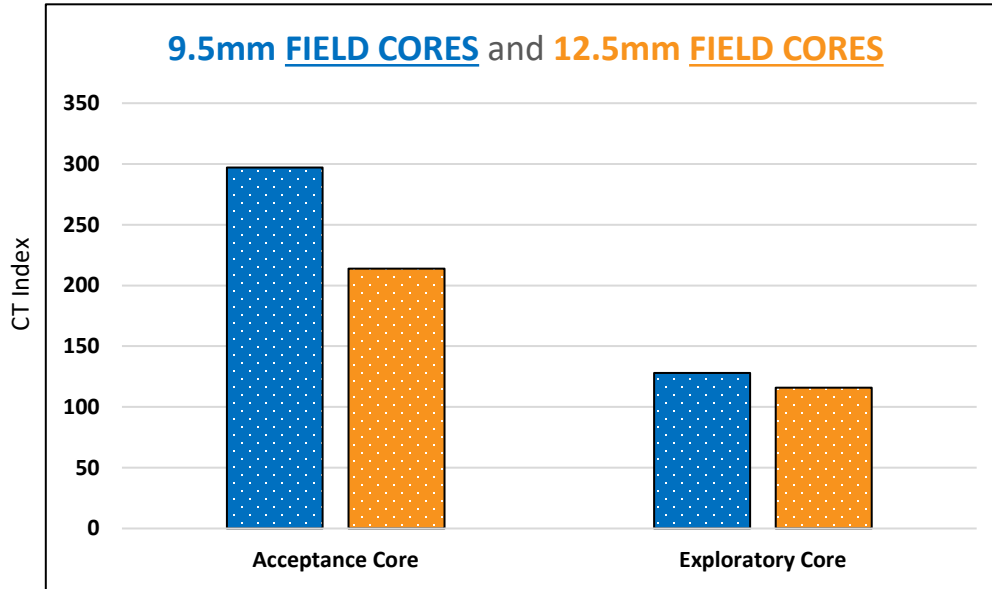
Establish a Baseline (Field Samples)

- Observed similar differences between Field Cores taken for acceptance and those obtained with 3+ years of service.

Acceptance	
	9.5	12.5
CT Index	297	214
St Dev	86.64	47.24
CoVar	29%	24%

3+ yrs Service	
	9.5	12.5
CT Index	139	115
St Dev	37.97	45.67
CoVar	28%	40%

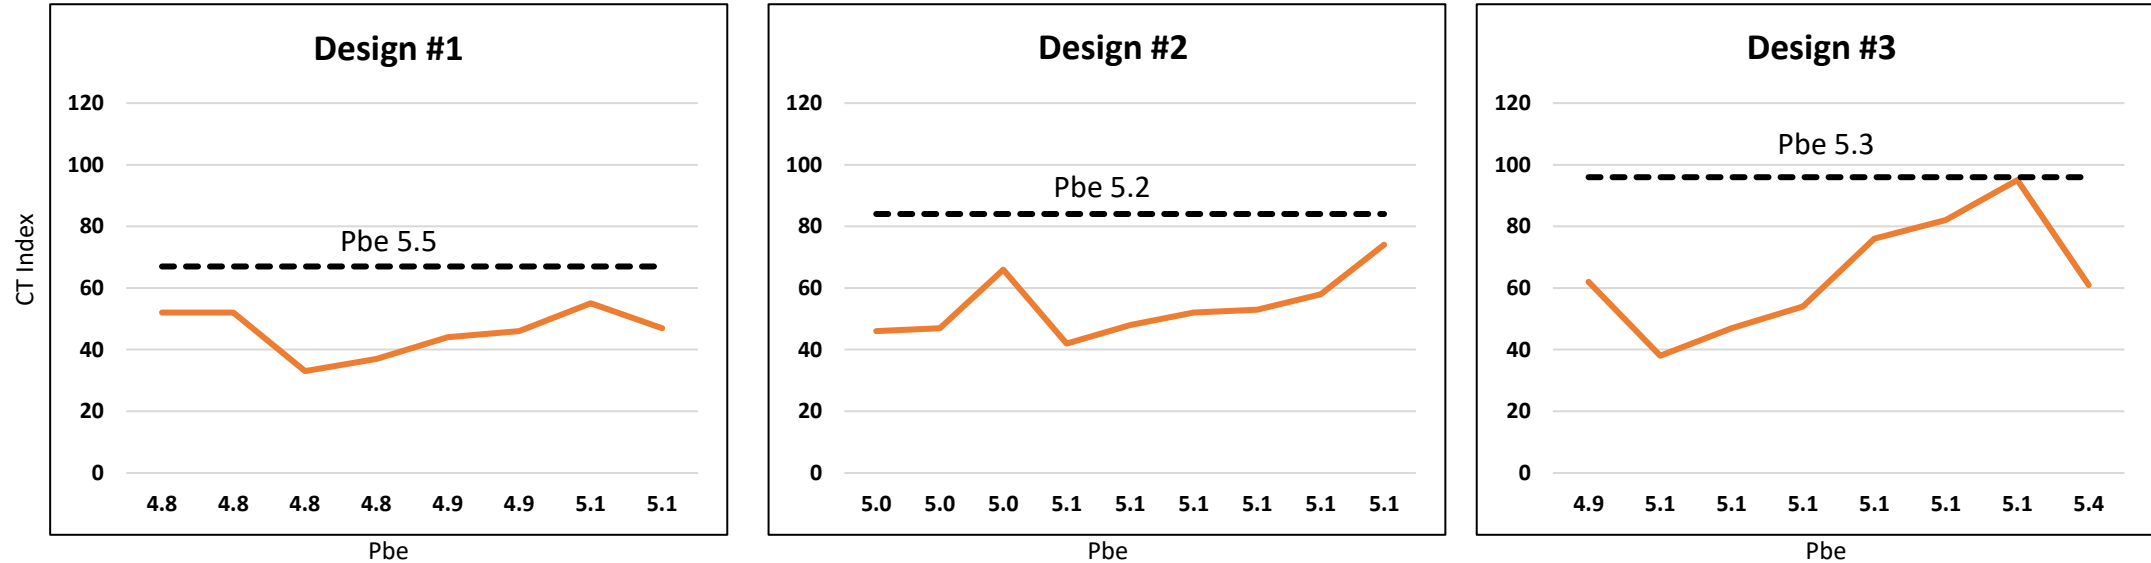
(Pbe) Design Samples vs Production Samples

Established a baseline of CT values with design samples; concentrating on Pbe.
Compared the design CT values with those obtained from production samples.

- Production CT values rarely achieved those of design. ??????
- Plant adjustments tended to increase the #200 (AC target can't be adjusted but production tended to run -0.1 from JMF)
 - ✓ 9.5mm 50% of producers had #200 PWL <90 (41% had #200 PWL <80)
 - ✓ 12.5mm 57% of producers had #200 PWL <90 (46% had #200 PWL <80)

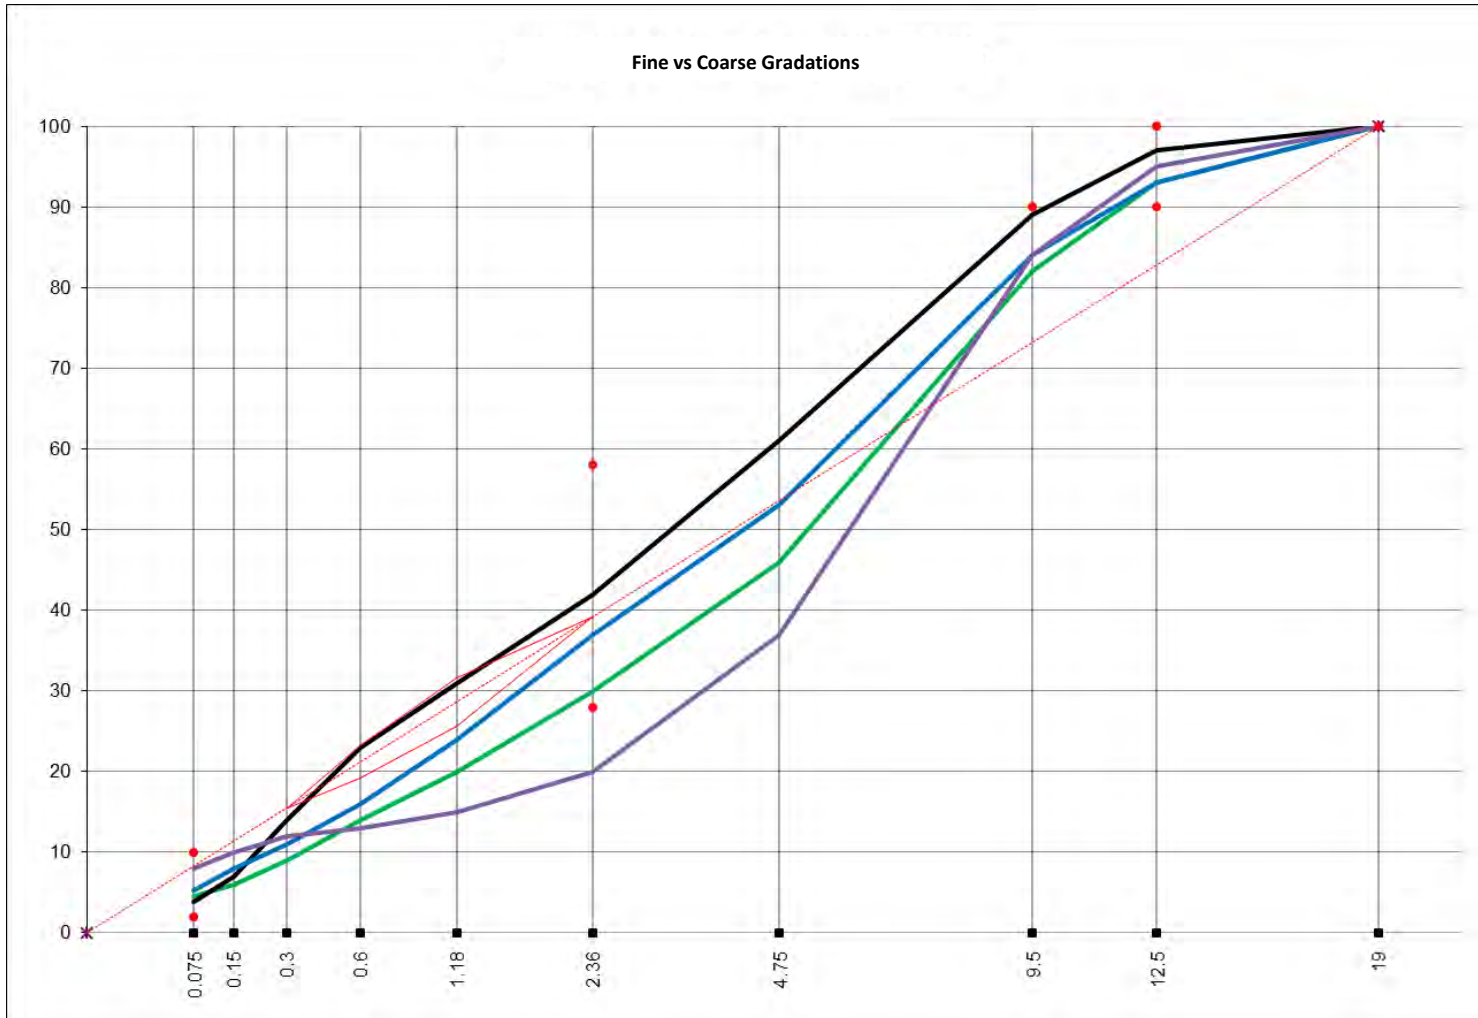
Fine Gradation vs Coarse Gradation

Pbe	#200	#8	#4	CT Index
#1 SR12.5	4.8	5.3	37	53	16
#2 SR12.5	4.7	3.8	42	61	23
#3 SR12.5	4.9	4.5	30	46	59
SMA12.5	6.4	8.0	20	37	181

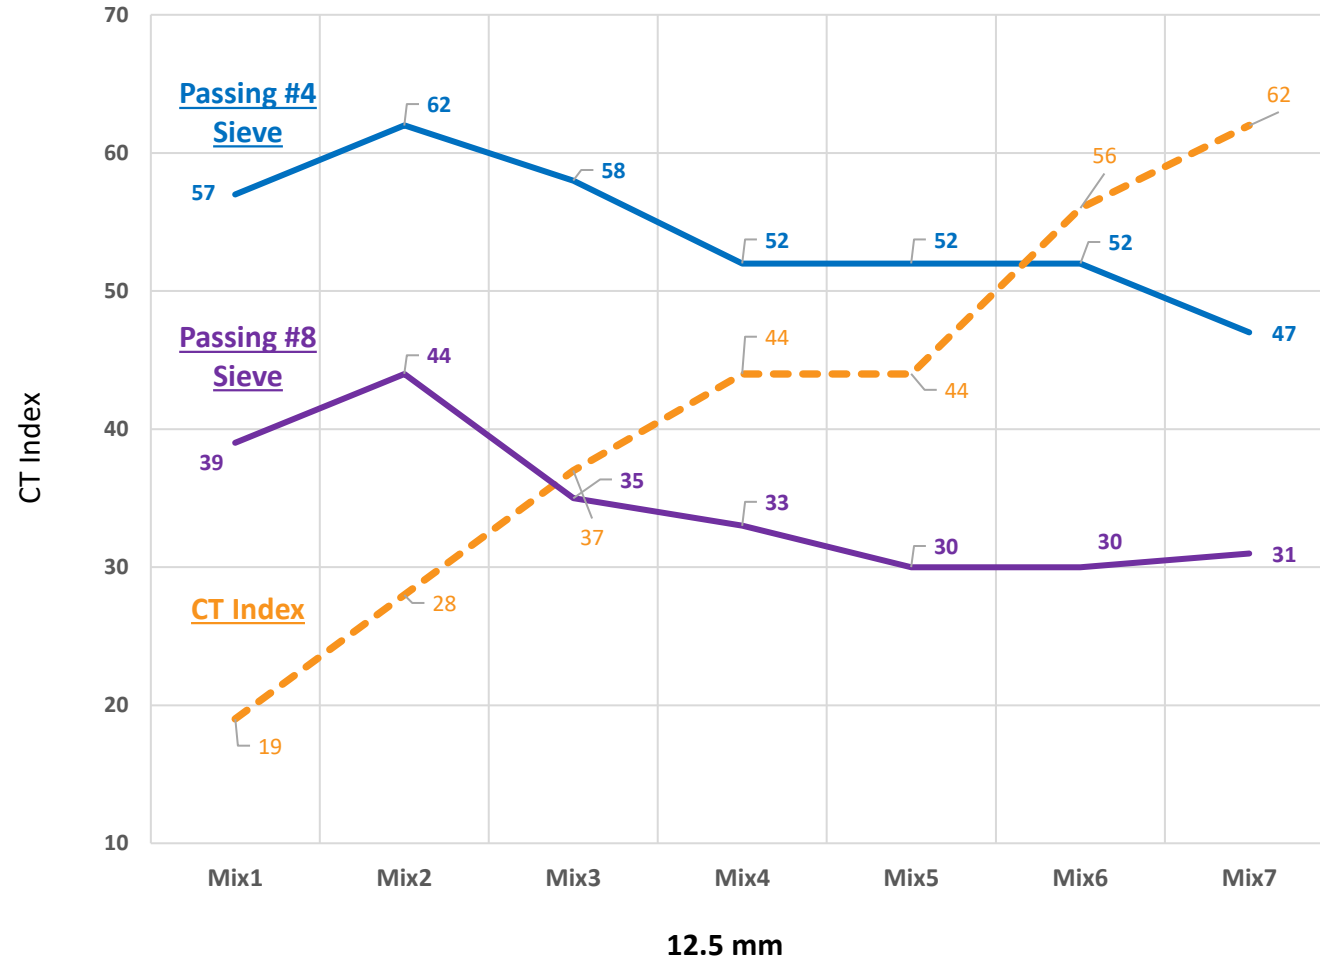
Effect of Gradation on CT Index (#8 & #4 Sieves)

CT Index	AC%	#8	#4
Mix 1	19	5.6	39	57
Mix 2	28	5.6	44	62
Mix 3	37	5.4	35	58
Mix 4	44	5.6	33	52
Mix 5	44	5.3	30	52
Mix 6	56	5.4	30	52
Mix 7	62	5.4	31	47

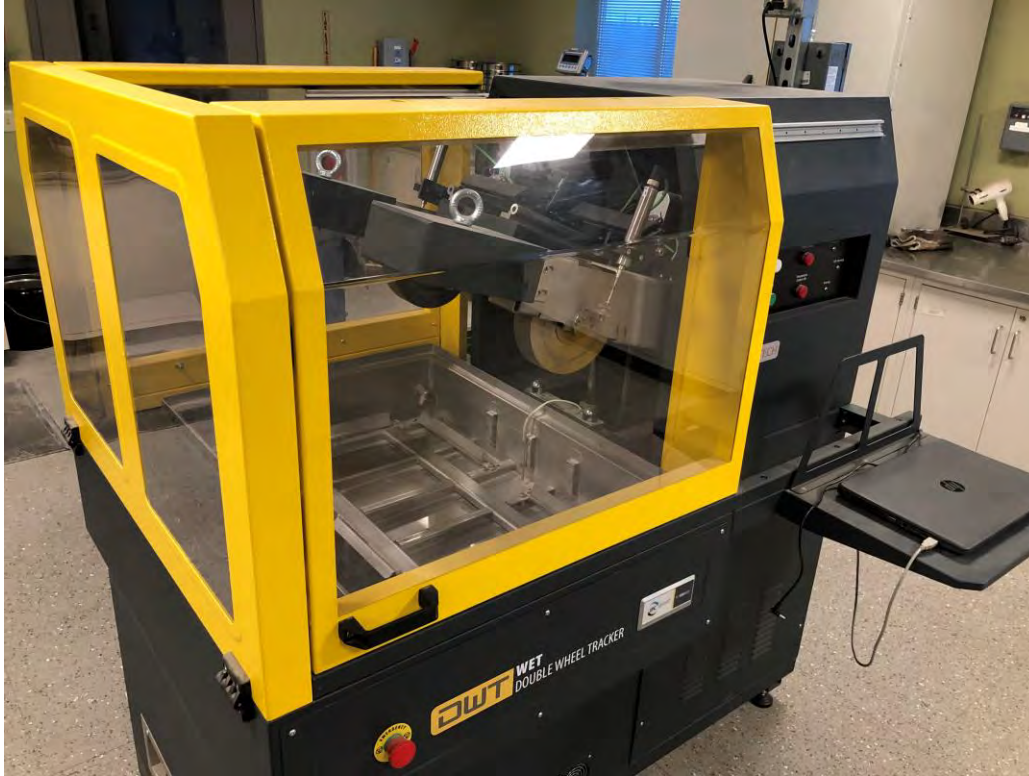
DWT Hamburg Testing

- Data collection in progress (Limited samples)
- 3 material classes (9.5, 12.5 and SMA)
- No significant rutting or SIP observed

Average Rut Depth:

9.5mm = 3.42 mm

12.5mm = 2.82 mm

SMA 12.5 = 4.82 mm

* Tested specimens beyond T324 specifications. Wanted to observe SIP or complete failure. (>10,000 cycles)
